THAT'LL BE TI

Engine: 1.9SDi 8-valve
VW models: Golf, Passat

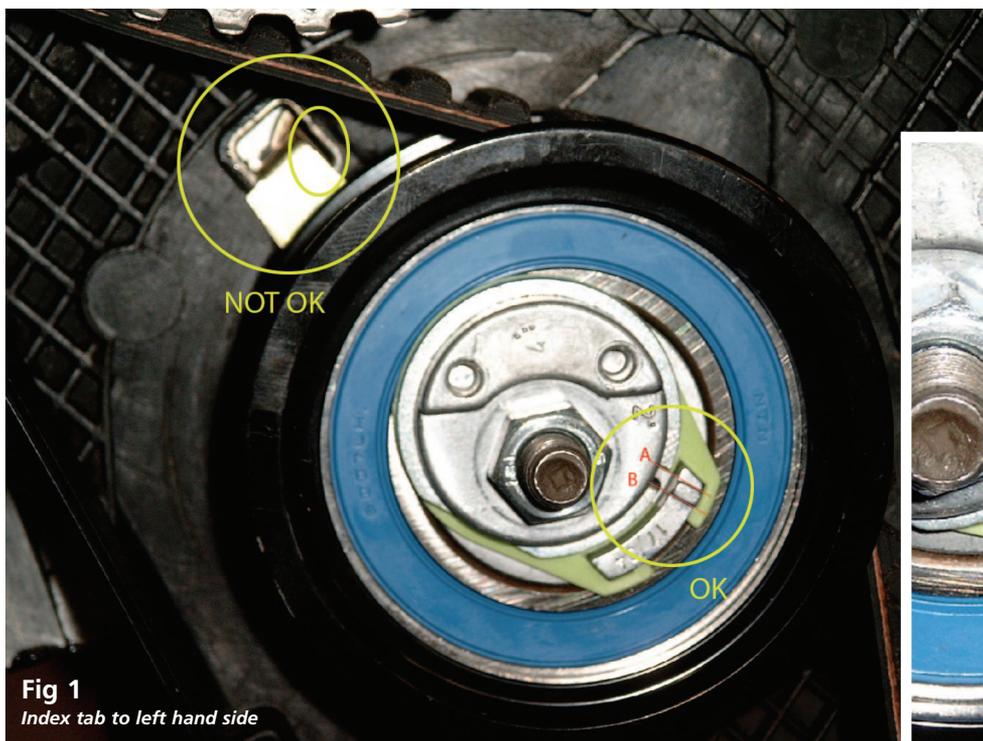
Fig 1
 Index tab to left hand side

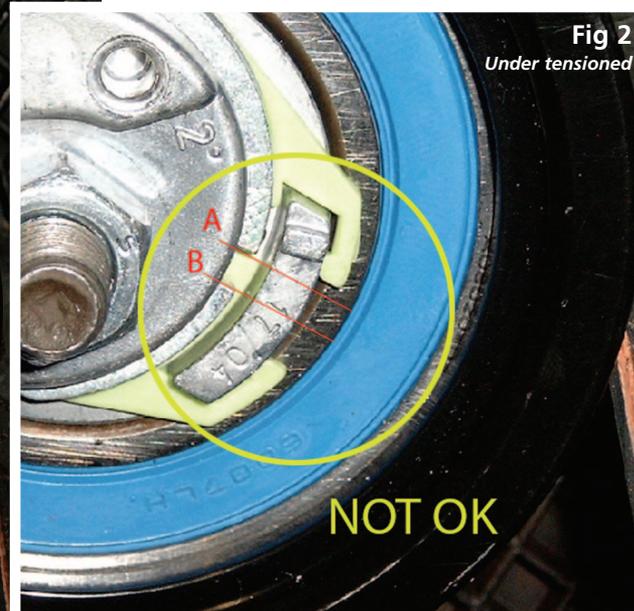
Fig 2
 Under tensioned
