PRECISION

SECOND SIGHT

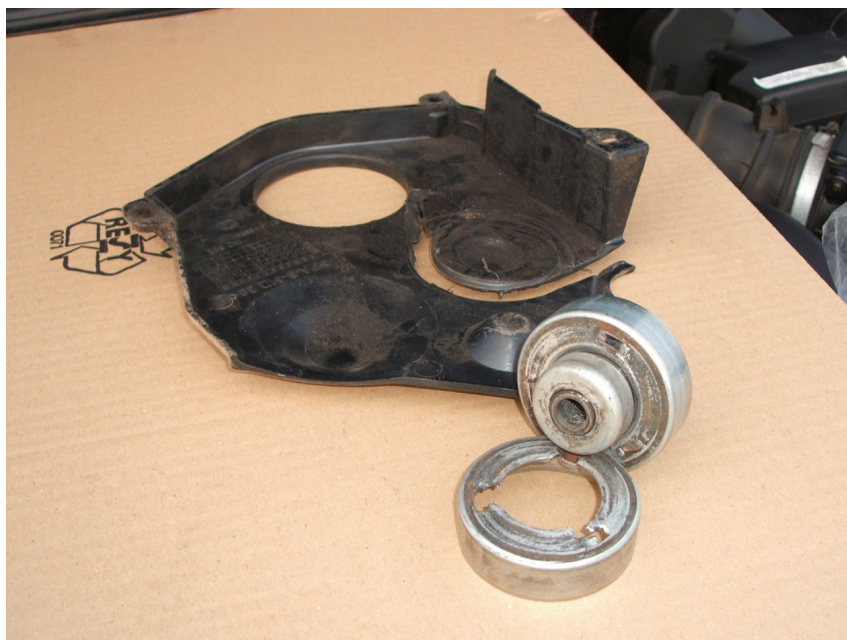
the increased stress on one side of the tensioner, the bond between the two halves was compromised and the rivets collapsed.

The technician had installed a complete timing belt kit, so all of the components were new. Once again, the tensioner had parted and the belt had broken. The belt had fouled the timing belt cover. As in the previous case, the belt had frayed on one side, before it had been completely destroyed. It was also clear that this wear had taken place on the side nearest to the timing belt cover.

Upon closer investigation, it was observed that within the overall layout of the drive system, the belt ran very close to the timing belt cover. The alignment must be precise. With this particular engine, any slight deviation of the belt can bring it into direct contact with the timing belt cover. Once the belt makes contact with the cover, it is drawn towards

the cover with potentially disastrous consequences for the engine.

As the belt frayed, 100% of the load eventually became concentrated on only 50% of the tensioner. With

In the first case, a belt kit was not installed, the belt had frayed and the tensioner had collapsed. It was only because a belt kit had been installed in the second case, that the real problem, an alignment issue, was identified. Gates recommends the use of a belt kit at every change and urges garages to implement a formal inspection procedure as a safety first approach. It should be included as part of a complete drive system overhaul.
