# ER PICTURE

## ASSOCIATED WEAR AND TEAR

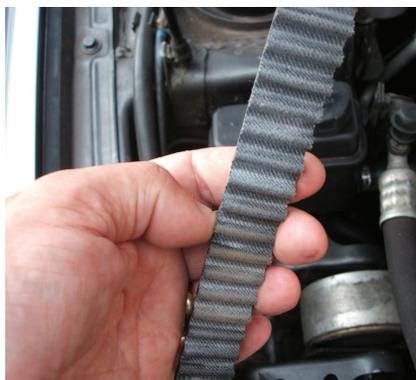
The Gates inspector was able to identify a leak from the water pump, another form of contamination. Water/liquid in the drive is a problem because, once it becomes trapped between the belt and the pulley, it cannot be compressed. It is subsequently forced into the belt material, which causes the belt to swell and eventually to mis-mesh.

In such circumstances, it's the mis-meshing that ultimately causes premature belt failure. It seemed likely that this leak had contaminated the drive and caused the most recently installed timing belt to fail.

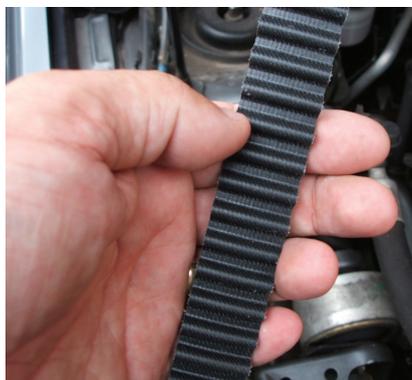
A possible scenario is that when the mechanic discovered the residue in the original inspection, a slight leak from the water pump was overlooked. The key to the mystery is the coolant. Antifreeze contains a range of chemicals in solution. When freely exposed to the hostile environment inside the drive system, not only could pressure from the action of the belt force some of the coolant into the belt material (as outlined above), but it would leave behind the powdery residue that the mechanic was quick to spot.

It's likely, therefore, that water, rather than any other form of contamination, was involved in both cases. It was the same water leak each time.

The moral of the story is never let evidence that points to just one suspect cloud your judgment. Examine the other components and rectify any problems that there may be before replacing the belt. Always consider the bigger picture.
