# 001

# Technical Bulletin

## Installation recommendations for timing system on GM 1.4, 1.6, 1.8, 2.0, 2.2 16V engines

<b>GATES REFERENCE :</b>	<b>5368XS, 5369XS, 5408XS, 5461XS, 5499XS, 5542XS</b>

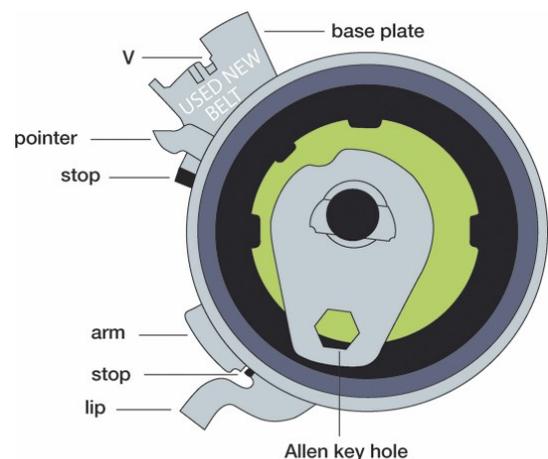
Fig. 1

- Align Top Dead Centre (TDC) marks. As the same engine used in a different model can have a different belt, we give the TDC marks following belt number here, and not following engine code.  
5369XS/5499XS: crankshaft: 5 O'clock, L-cam: 3 O'clock, R-cam: 9 O'clock  
5368XS/5408XS/5461XS/5542XS: crankshaft: 6 O'clock, camshafts 12 O'clock.
- Block camshafts
- Loosen tensioner bolt
- Turn tensioner clockwise and remove belt
- Remove old tensioner
- Install new tensioner, hand tighten bolt. Tensioner lip **has to be** in oil pump housing slot. (Tensioner pointer has to sit behind water pump pulley). The Allen key hole has **to be set** in +/- 7 O'clock position (fig. 1).
- Install new belt anti-clockwise starting at crankshaft

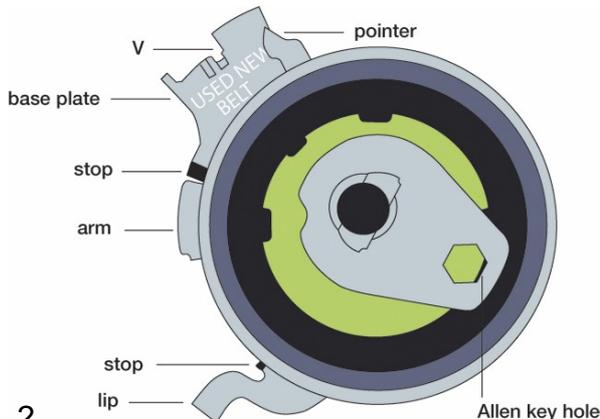
Fig. 2

- Turn tensioner (with Allen key) anti-clockwise (while holding the bolt in place) till pointer is in line with (not passing) right hand side of base plate (fig. 2)

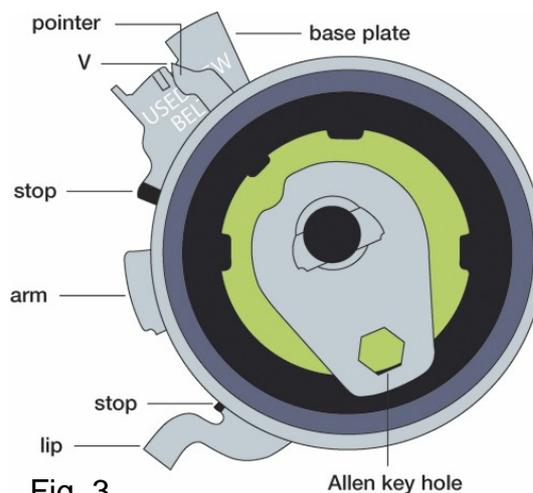
Fig. 3

- If pointer not in line with V ("NEW" position), bloc camshafts again
- Loosen tensioner bolt
- Adjust tensioner (while holding the tensioner bolt in place), till pointer in line with V ("NEW" position); the Allen key hole has to be in +/- 5 O'clock position now (fig. 3)
- Tighten tensioner bolt (+/- 20 Nm)
- Unblock camshafts
- Turn engine 2 revolutions (via crankshaft), till TDC marks align again
- Check tensioner pointer position. If correct (in V) install other removed parts. If not correct, do repeat steps 13 to 18, till pointer aligns with V.

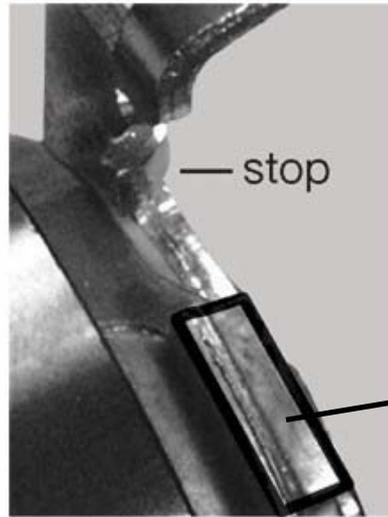
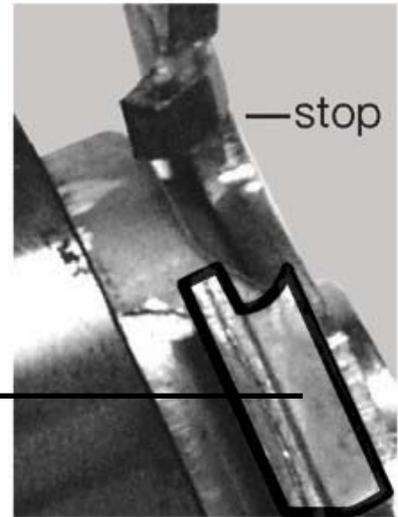
Fig. 4

Rotating the tensioner in the wrong direction, having the Allen keyhole in a wrong position to start off, not turning the engine 2 revolutions before and after setting the tension, can lead to system failure. This will cause the arm of the tensioner to hit the stop, creating a hammering noise, damaging and possibly even rupturing that part. This failure mode is very common and can easily be recognised when inspecting the edge of the arm (fig. 4). The resulting wrong tension can cause the belt to rupture.

"normal"

"damaged"
