Technical Bulletin

Installation of tensioner used in PowerGrip® Kits K015543XS, K025543XS and K015559XS

GATES REFERENCE :	K015543XS, K025543XS and K015559XS
MAKE :	AUDI / SEAT / SKODA / VOLKSWAGEN
MODEL :	A3, Cordoba, Ibiza, Inca, Leon, Toledo, Octavia, Bora, Caddy, Golf, New Beetle, Polo
MOTOR :	1.9 SDi / TDi
MOTOR CODE :	AGP, AGR, AHF, ALH, AQM, ASV, ASY, AYQ

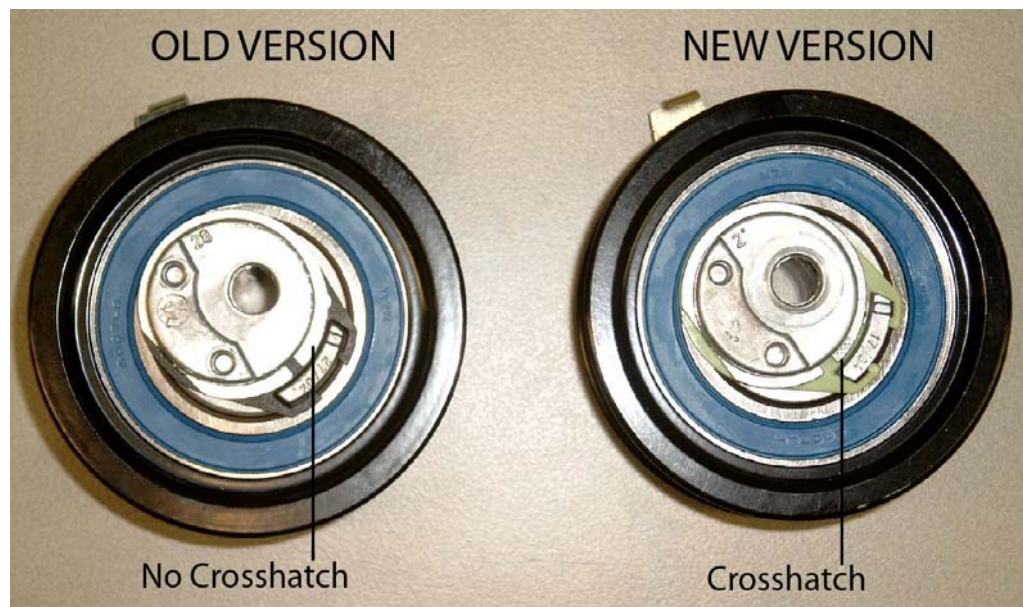
In Fig. 1 you can see that only the new version has a crosshatch belt wear indicator (see also Fig. 4). This section indicates when the timing belt is worn out and when it needs replacement.

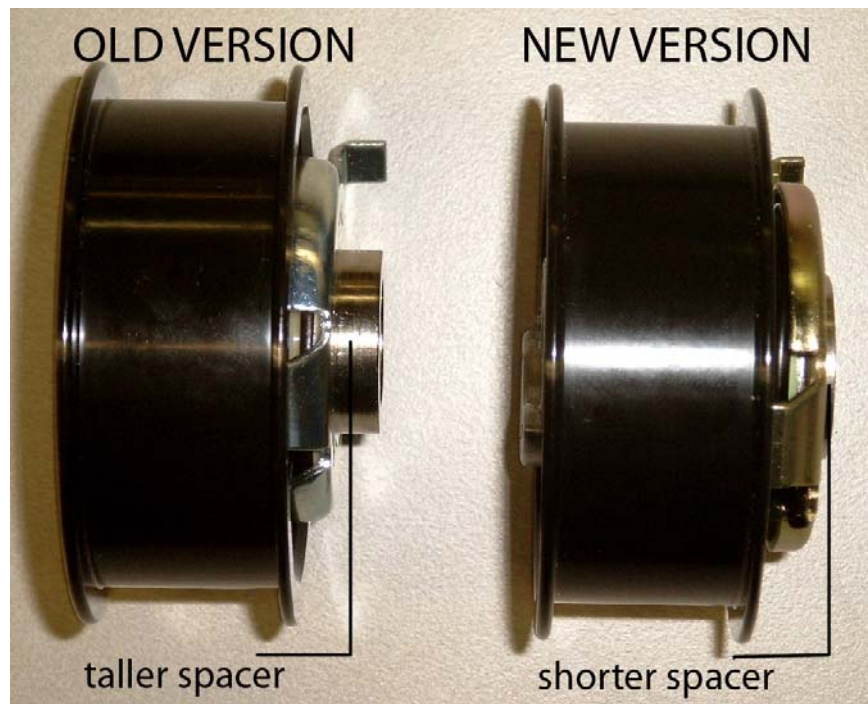
In Fig. 2 you can see that the new tensioner also has a shorter spacer. However, the distance between the engine block and the pulley remains the same.

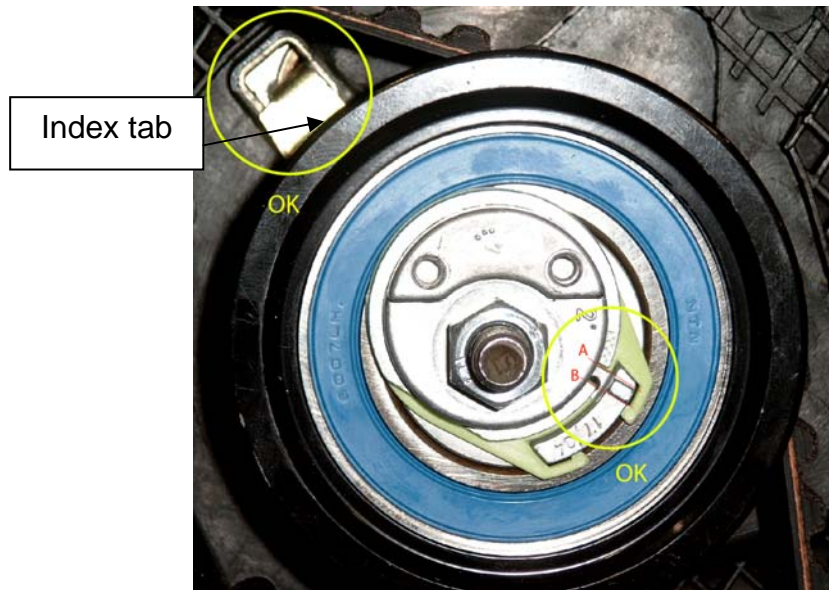
Fig. 3

When after two engine revolutions the pointer is between lines A and B and the index tab is **in** the slot and pushing against the **right hand** side (Fig. 3 and Fig. 4), only then the tensioner is perfectly positioned.

When the new tensioner is installed, verify that the index tab is located and properly seated in the slot (Fig. 3 and Fig. 4). Use the special tool to tension the tensioner and turn clockwise until the pointer lines up perfectly in the window, between the lines A and B. You can use a mirror to properly see this in the engine compartment. Now tighten the bolt at 23Nm.

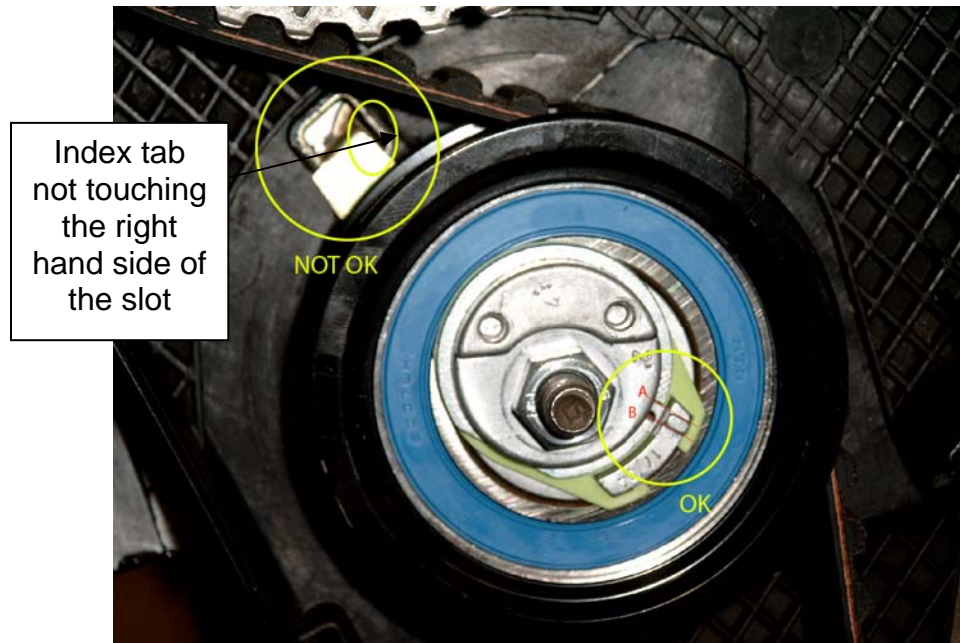
Fig. 5 shows one of the common errors. Pointer is perfectly positioned between lines A and B but the index tab is not OK. The index tab is in the slot but is not pushing against the right hand side of the slot. The reason for this is that the tensioner was moved anti-clockwise during the tensioning process.

When you are in the tension-setting, never turn the tensioner anti-clockwise!

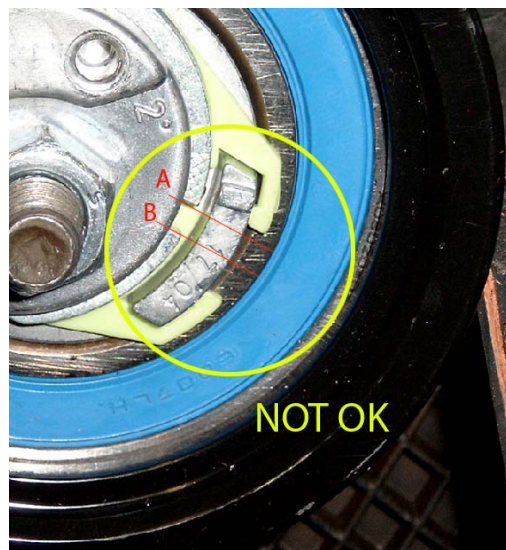
Fig. 6

A second possible error can be seen in Fig. 6. You can see that the pointer has not passed line A and is in front of the crosshatch. This means that the belt will have a too low tension.

If the pointer is not well positioned, the mechanic should restart the tension-setting procedure completely.

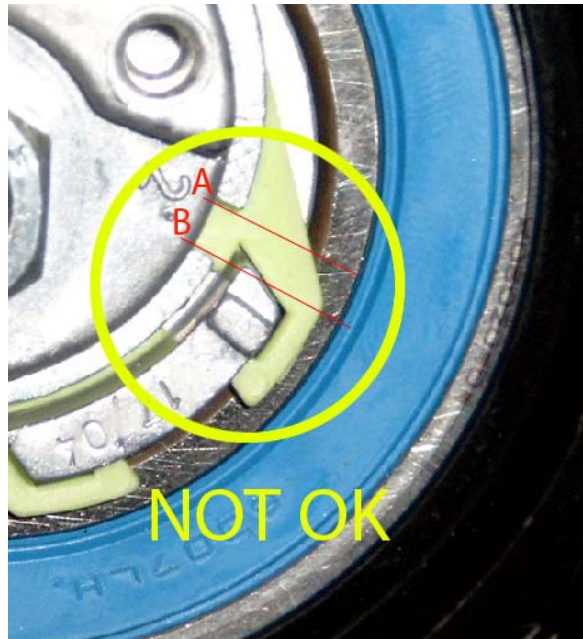
Fig. 7

A third installation error is shown in Fig. 7. The pointer has passed line B, this means that the belt will be tensioned too much.

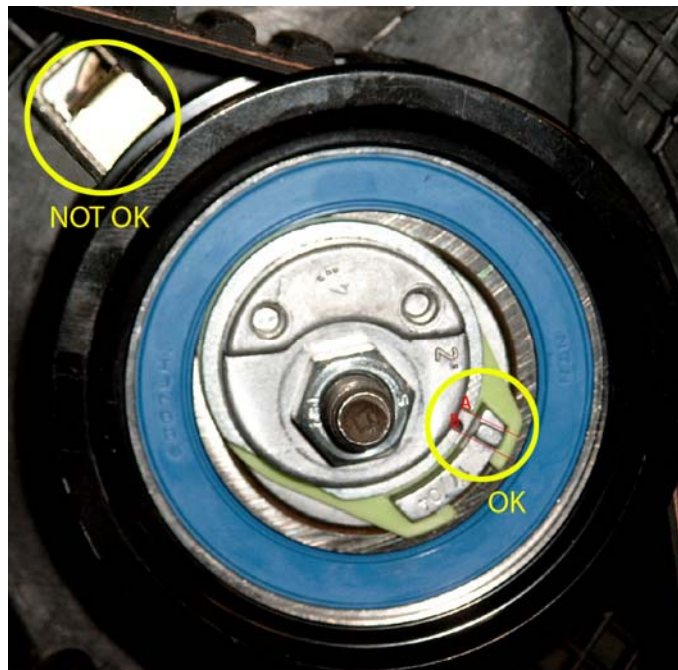
In Fig. 8 you can see a fourth error where the index tab is not locked in the slot although the pointer is perfectly positioned between lines A and B. This way the belt will lose its tension once in operation.

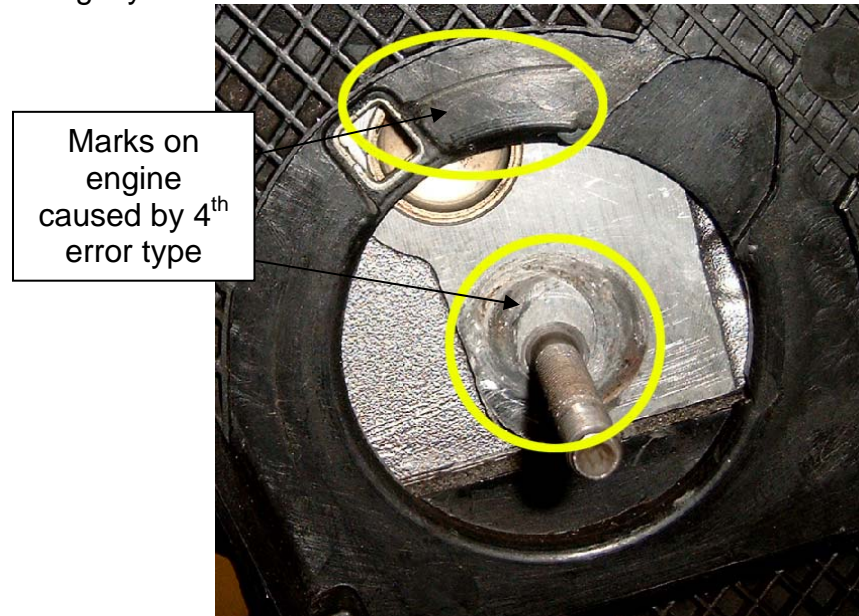
Fig. 9

You can see the marks on the engine caused by this type of wrong fitment in Fig. 9. In this case you will also see that the index tab on the tensioner is slightly bent over.

When the vehicle is released with a wrong positioned tensioner, severe engine damage will happen sooner or later.

We can not stress enough how important it is to follow all the steps in the process of installing this tensioner without skipping one of them. It is better to lose 5 minutes at the installation then to lose an entire engine in the end.
