Timing belt/kit installation on GM (Isuzu) 1.7D engines

5563XS/K015563XS/K025563XS/K035563XS

CHEVROLET, OPEL, VAUXHALL

A17DT, A17DTR, Y17DT, Y17DTH, Y17DTL, Z17DT, Z17DTH, Z17DTR

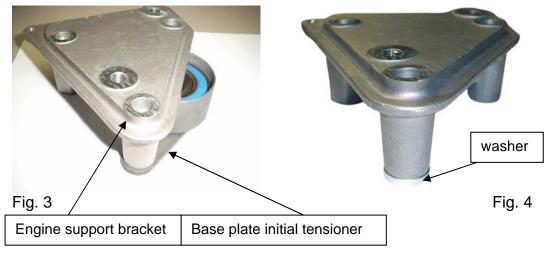
As the initial tensioner base plate was sitting under one of the legs of the engine support bracket (Fig. 3), K015563XS can only be used from engine nr 328704 on.

K025563XS is supplied with a washer to compensate for the shorter leg of the early engine support bracket (Fig. 4), and a stud which is needed to hook the new tensioner spring on (Fig. 5). This K02 can always be used: up to engine nr 328703, using the washer and the stud; and from engine nr 328704 without the washer and the stud.

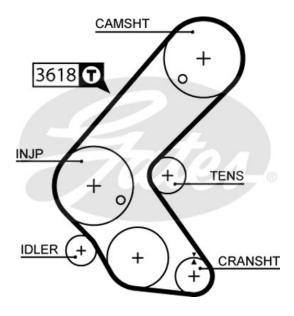
Fig. 7

, (see drive system layout below - Fig. 7) using the Gates Sonic Tension Tester STT-1.

To do this, enter the code 3618 in the STT-1 (ensure chip version 006 is installed) and measure in the normal way. If the tension is too high then the tensioner should be completely released and tensioning procedure repeated until the green light is obtained.

If the tension is too low then it will be necessary to assist the tensioner spring with the Allen key; until the green light is obtained.
