The reconstruction of an installation procedure resolves a short running timing belt mystery after two similar incidents less than 100 miles apart.

A seized tensioner in the drive system on a 1.9 TD Renault Megane (F8Q engine) was the key suspect in the premature failure of a timing belt that had been fitted by an installer in the North West of England. Intrigued by the similarity to a troublesome — and as yet unresolved — case just across the Pennines in West Yorkshire, the Gates inspector was pleased to be given the opportunity to give an opinion at the scene.

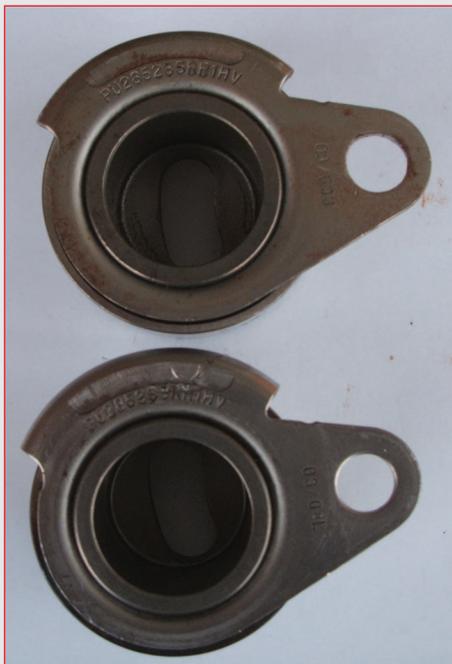
Closer examination of the surviving pulley on the second vehicle suggested that a similar pattern of behaviour had been in progress. The blue tint around the outside edges of the pulley is entirely consistent with problems arising from a seized tensioner. However, the condition of the tensioner itself was

Fig 1. Top image: A new backplate. Bottom image: 'Scoring' on backplate. Note the crescent markings at the top of the flange.

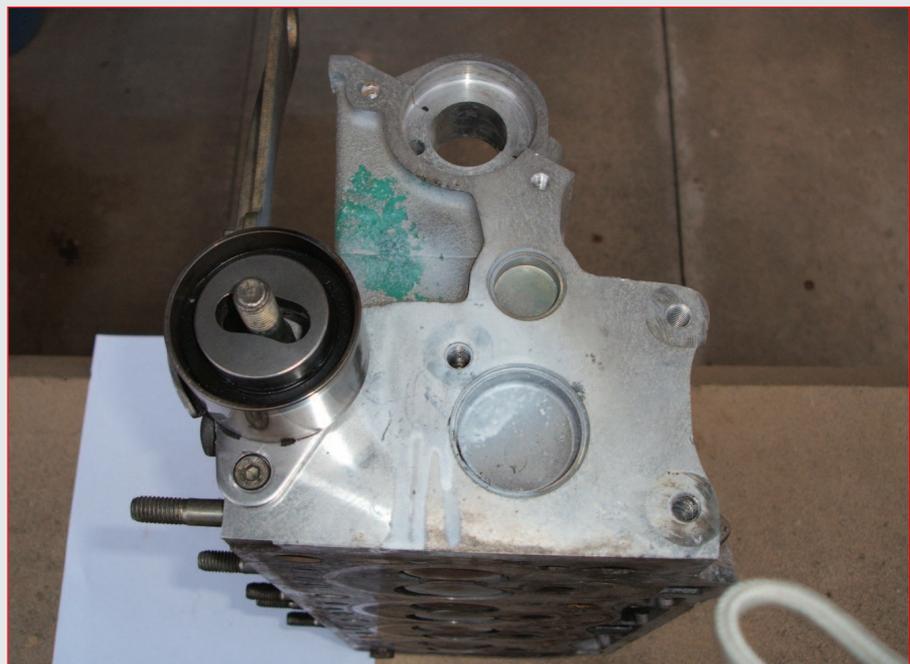
Fig 2. Tensioner is fitted securely, over the stud below the tensioner, in the correct position.
