ANALYSIS

INSPECTOR'S DIAGNOSIS

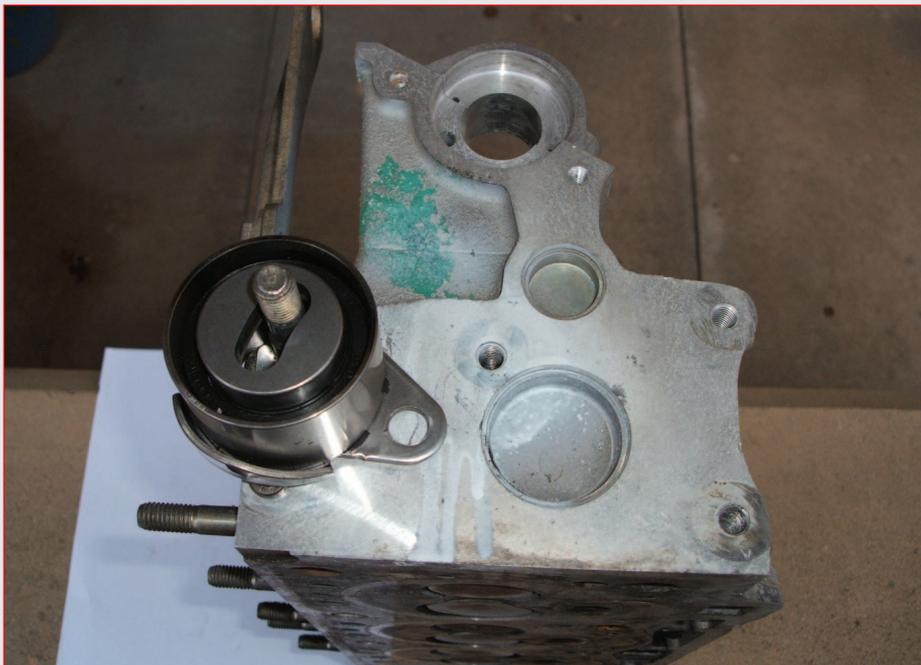
correctly seated, there can be no contact with the backplate of the tensioner. However, if the locating peg is not properly engaged (Fig 3) when the locking nut is secured, the backplate is able to make contact with the locating peg. By rotating the tensioner manually, the crescent-like scoring on the back plate was reproduced. It was the same as that identified in each drive on both engines on either side of the Pennines.

Nobody was negligent in either case. The re-enactment showed how easily the locating peg can be disengaged before securing the locking nut. As the securing nut is tightened, the backplate can buckle or bend. Contact between the locating peg and the backplate causes the crescent-like markings and seizes the tensioner. For both mechanics, it was just a case of 'one of those things'.

Fig 3. Tensioner is fitted incorrectly and is not securely located.

It is essential that all of the components in the drive are located precisely and set up correctly. Once the installation tension of the belt has been accurately set and a visual check has been made for alignment, turning the engine over by hand is a worthwhile exercise in order to ensure that the drive pulley and all tensioners are operating and moving efficiently. Torque settings must also be checked according to the manufacturer's recommendations.
