# UNITY SEIZED

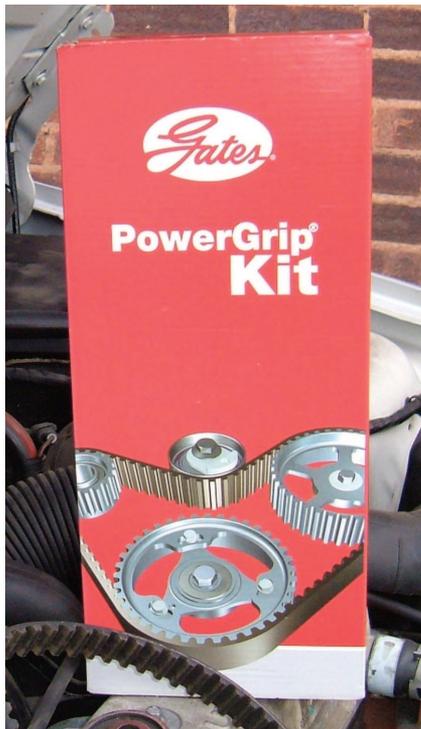
The timing belt in the Ford Escort had worn so badly that only debris from the teeth and fibreglass cords remained. The condition of the tensioner was almost identical to the

one that had been reported on the Mondeo. When this drive system was examined, however, it soon became clear that the water pump had completely seized. It was solid! There was little doubt that the heat generated had the potential to cause the premature failure of the timing belt as well as the subsequent melting of the pulley on the tensioner.

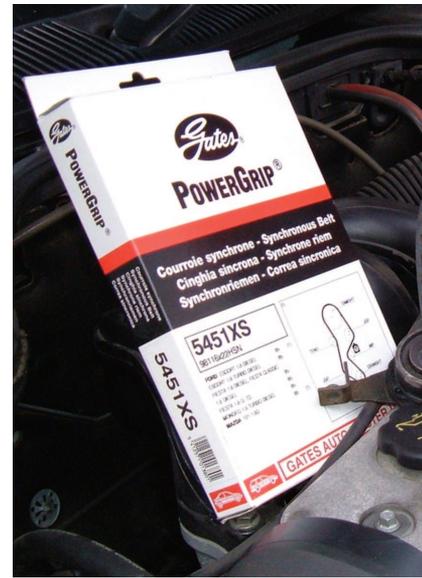
The water pump on the Endura engine is driven from the flat side of the belt rather than being driven by the teeth. Any seizure of the water pump would cause the belt to rub against the pulley, causing friction and generating heat. The modern belt is designed to withstand extreme engine temperature. The friction, however, caused an abnormal amount of heat to be absorbed by the belt. That heat was then transferred to the surface of the tensioner, causing the pulley to melt. The sequence of events would take place very quickly after the initial seizure.

worthwhile. In these cases, it was impossible to determine whether the water pumps could complete a second duty cycle. The conclusion is that they should be replaced. That's what is meant by a complete drive system overhaul!
