Certain issues should always be considered when replacing timing belts. Gates reports on the causes of premature failure.

CASE STUDY

Manufacturer: Nissan
Model: Micra K10
Engine: 1.0 litre
Year: 1990

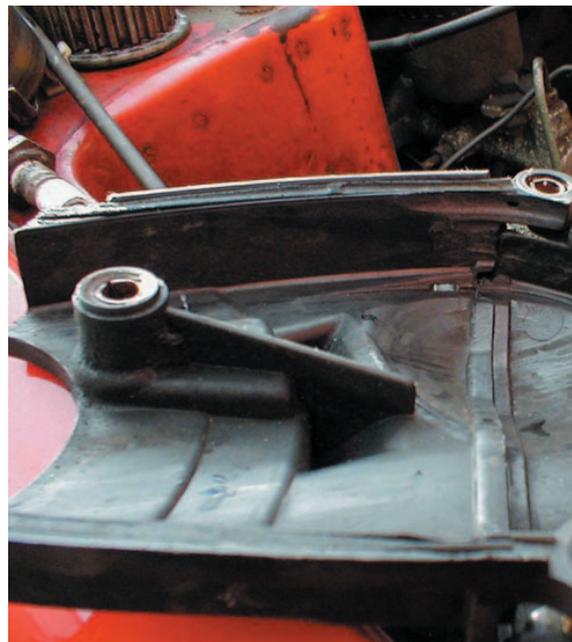
tension of the belt. Damage to the belt itself could indicate a misalignment issue. A foreign body (stone-chips, for example) could be a cause. In the case of the Nissan Micra, the belt had been shredded. If

shredding occurs on the inside-edge, evidence of scouring or scuffs on the engine block is likely. On this occasion, the damage had been caused on the outside-edge and the evidence was visible on the timing belt cover.

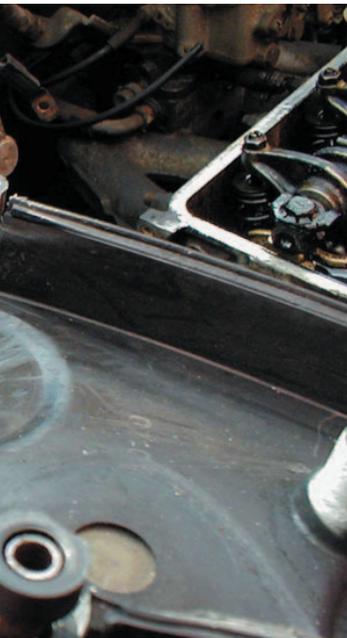
The picture below shows the arc created by the belt as it ran against the timing belt cover. This usually occurs because the belt has tracked in the drive system and is running out of alignment. In this case, the belt came into contact with the timing belt cover, causing wear on the belt and created a hole, which can be clearly seen. The belt was eventually destroyed, with devastating consequences for the engine.

In order to determine the cause of the misalignment, all of the related components were examined. As the oldest component in the drive system, the tensioner was a prime suspect. Sure enough, there was evidence of 'play'. The bearing could be moved with very little effort from side to side.

A leaking water pump would normally suggest significant wear to the pump's bearing. It also suggests that other components in the drive system are also worn (ie tensioners and pulleys). There was no doubt that the tensioner was the cause

of the misalignment. The worn tensioner should have been replaced when the new belt was fitted. This belt had very little chance of completing a full duty-cycle.

Timing belts are vital components in today's technologically laden engines. The metal parts of the drive system should be replaced every time the belt is changed. That's because the technician — and indeed the garage proprietor — can have no reasonable expectation about the future performance and longevity of the metal parts that are in-situ.
