# SPOT THE D

## CASE STUDY I

**Vehicle:** VW

**Model:** Passat

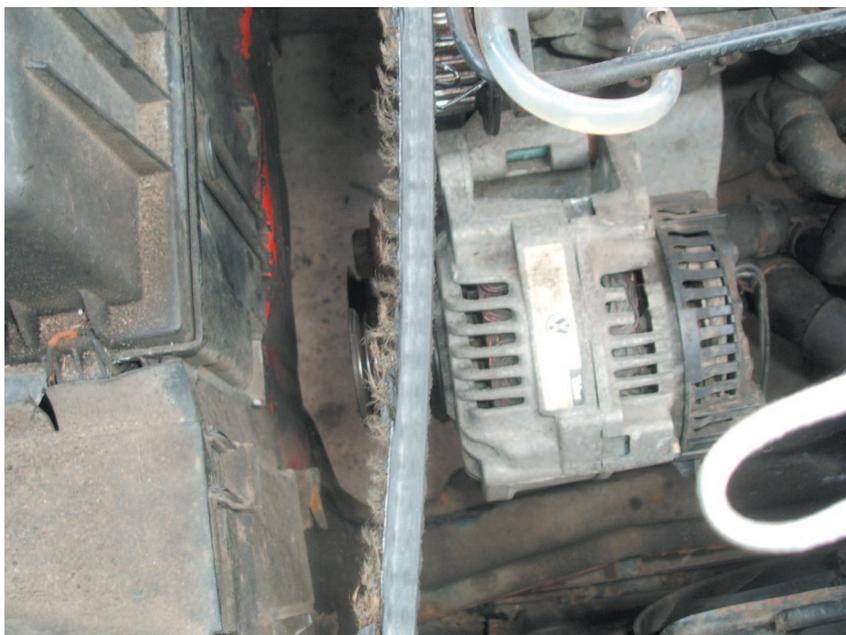
With the drive system cover removed, all the usual signs of misalignment were in place. Apart from the audible evidence – the noise, which had initially drawn the attention of the motorist – there was visible evidence (see picture A).

- Frayed edge to the timing belt itself.
- Reduced width.
- Fibre residue in the drive system.

The presence of these confirmed it was a clear-cut case of misalignment. So what was the cause? It was time to look for likely contributors.

distortion of this bracket will have an adverse affect on the orientation of the injection pump. If the bracket has become bent for any reason, as proved to be the case, the timing belt will be compromised from the start. In this instance, a bent bracket meant that the belt was not running true. This distortion of the bracket may have been caused by any number of different factors during the operational lifetime of the vehicle. Whatever the specific cause, the result was that the timing belt began to 'track' within the drive system.

Changing the belt alone could not resolve the problem. The bracket had to be restored to its original condition to prevent misalignment from re-occurring.
