Technical Bulletin

Accessory drive on Renault 1.5 DCi engines

GATES REFERENCE :	Accessory drive	 
MAKE :	RENAULT	
MODEL :	Clio II, Express, Kangoo, Rapid, Symbol	
MOTOR :	1.5 dCi	
MOTOR CODE :	K9K700, K9K702, K9K710

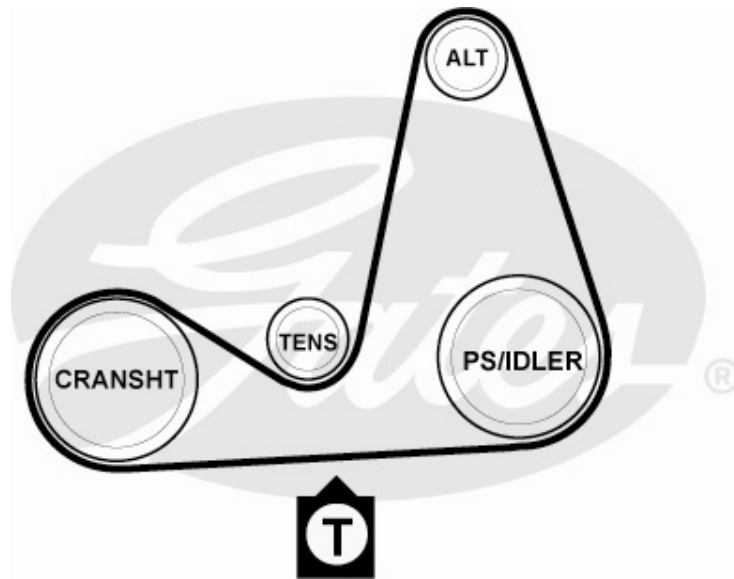
Fig.1

Measure the tension in the bottom span, between the crankshaft and power steering pump (or idler for cars without power steering) (Fig.1).

When measuring the belt tension with the STT-1, key in "8", "180" (virtual span of 180 mm). When measuring with the Krikit[®], tension has to be 70 Kg.

Now tighten the 2 bolts (36 Nm).
Rotate the engine 2 revolutions clockwise.

Check the tension and adjust if needed.
Re-install all removed parts.
