027

Technical Bulletin

FORD 1.8 Diesel engine.

GATES REFERENCE :	5541XS/K015541XS
MAKE :	FORD / MAZDA
MODEL :	C-Max, Courier, Fiesta, Focus, Galaxy, Mondeo, S-Max, Tourneo Connect, Transit Connect
ENGINE :	121 1.8 Diesel (all 8 valves)
ENGINE CODE :	Various

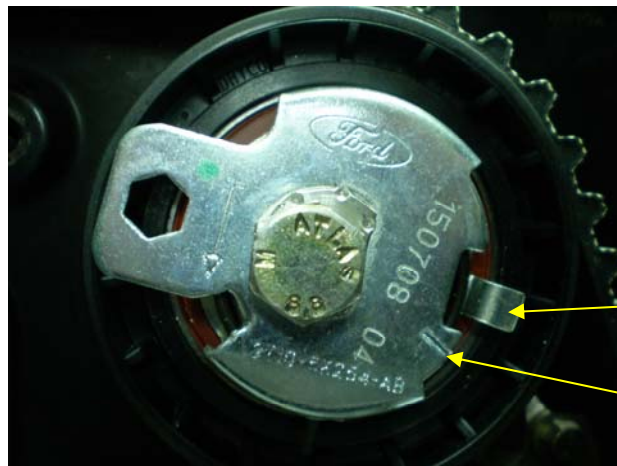
Fig. 1

Indicator in middle of the slot. ✓

Mark on the tensioner

- 1) Engine must be cold: the engine temperature significantly influences the installation parameters
- 2) Engine must be at TDC. All engine specific setting/locking tools can be found in Gates tool kit GAT4830
- 3) The crankshaft has to be blocked (when equipped with air conditioning, the alternator shaft has to be removed, 6 bolts to loosen).
- 4) The camshaft has to be blocked (at the back of the engine)
- 5) Camshaft sprocket bolt has to be loosened. Make sure sprocket is free to rotate on the taper, by using the sprocket remover in tool kit GAT4830 (if not done so, the belt will not be tensioned in the top span)
- 6) The tensioner must be turned anticlockwise, until the indicator is in the middle of the slot (not lined up with the mark on the tensioner) (Fig. 1)

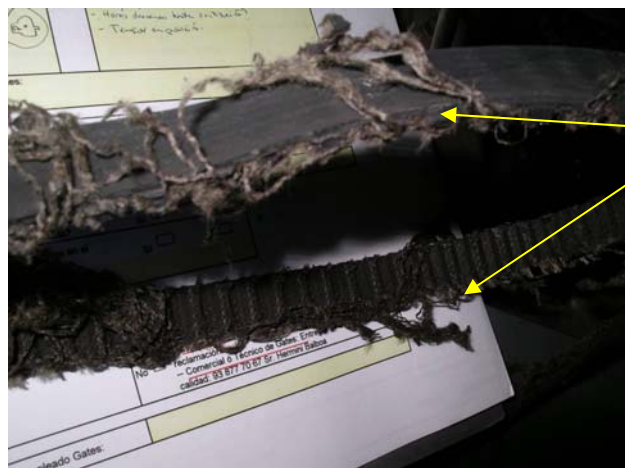
Failure to do all the above will lead to wrong tension, with possible tracking of the belt as a result. The belt will climb over the camshaft sprocket flange, running into the timing cover (Fig. 2 and 3)

Fig. 2
Typical wear pattern on the side of the belt

- 7) Torque the tensioner bolt (50 Nm) **while holding the tensioner in place**
- 8) Torque the camshaft bolt (50 Nm) **while holding the sprocket in place**. Use Gates sprocket holding tool GAT4844.
- 9) Remove the camshaft and crankshaft locking tools
- 10) Turn the engine nearly 6 revolutions by hand
- 11) Re-insert crankshaft pin, rotate engine further till TDC
- 12) Check the tensioner indicator position, if not in the middle of the slot, restart the tension setting procedure
- 13) Insert the camshaft locking tool (at the back of the engine). If not possible, restart the tension setting procedure

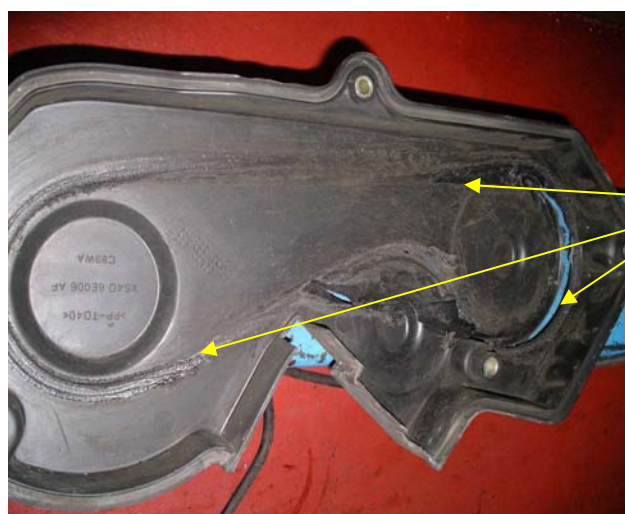
Fig. 3
Signs of serious wear on inside of the cover due to contact with the side of the belt

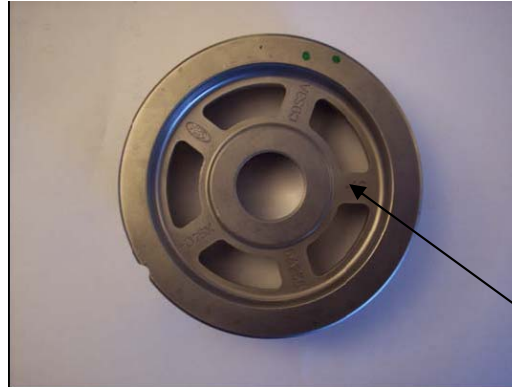
Fig. 4

Extension AC

Check if the part number of the camshaft pulley ends with **AC** (Fig. 4). Should the part number of the camshaft pulley end with **AB**, fit new sprocket with OE ref. XS4Q6A256**AC**.

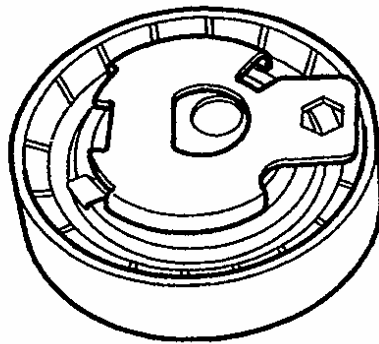
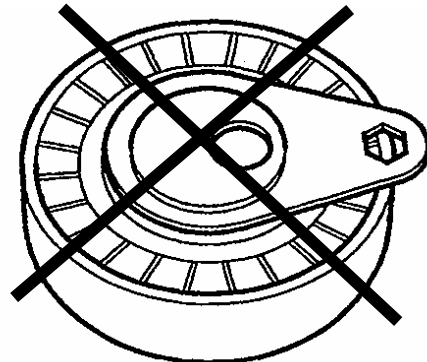
New automatic tensioner

Old manual tensioner

Fig. 5 shows the initial manual tensioner on the right side and the current automatic tensioner on the left.
