Technical Bulletin

VAG 1.9, 2.0 TDI – Auxilliary drive.

T38306/5PK1435

Audi, Skoda, Volkswagen

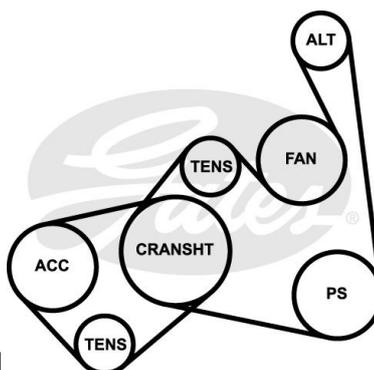
Fig. 1

The layout of the drive is shown as the alternator drive in Fig. 1. As this is a demanding drive, the alternator pulley is of the overrunning (free wheeling) type and the crankshaft is equipped with a Torsional Vibration Damper (TVD).

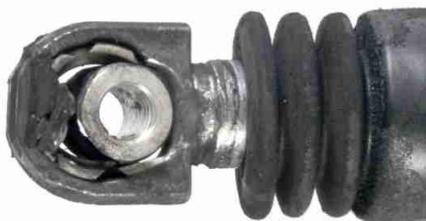
Fig. 2

An Overrunning Alternator Pulley (OAP) which is not working properly will create even more belt vibrations and noise. This can lead to excessive wear of the fixing hole at the top of the hydraulic actuator. (Fig. 2)

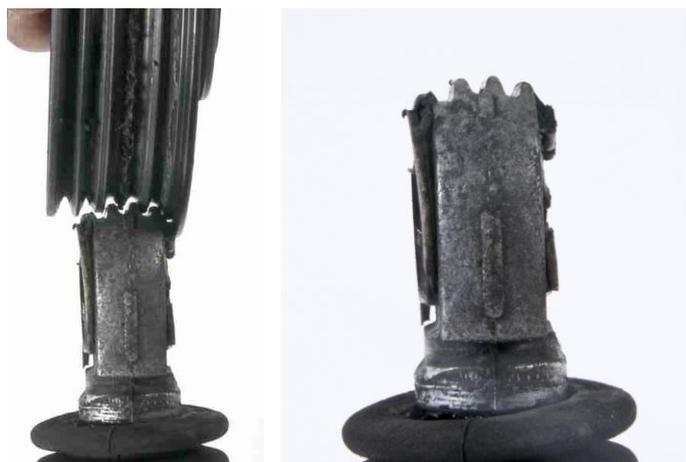
Fig. 3

This play can become enormous, leading to the tensioner body touching the tensioner pulley, causing a lot of noise. In its extreme form the tensioner body will even get grooved, because the pulley is "grinding" it. (Fig. 3)

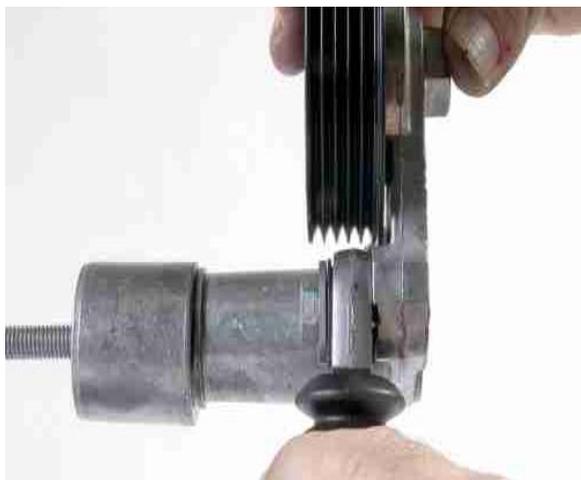
Fig. 4

In new condition, the free space between pulley and tensioner is 5 mm. (Fig. 4)

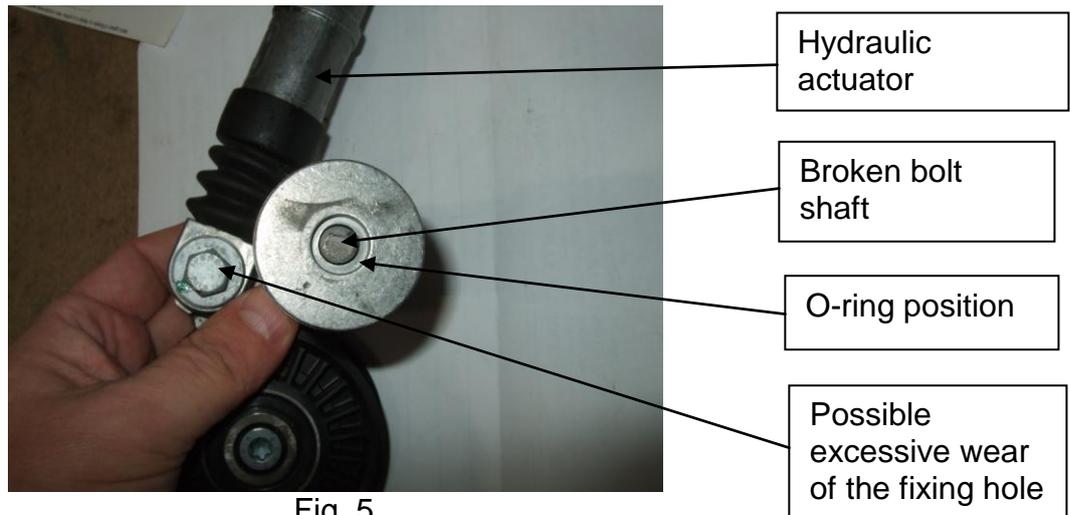
Fig. 5

Also the installation torque of the tensioner mounting bolts is critical. Failure to apply the correct torque will usually lead to the central mounting bolt shearing.

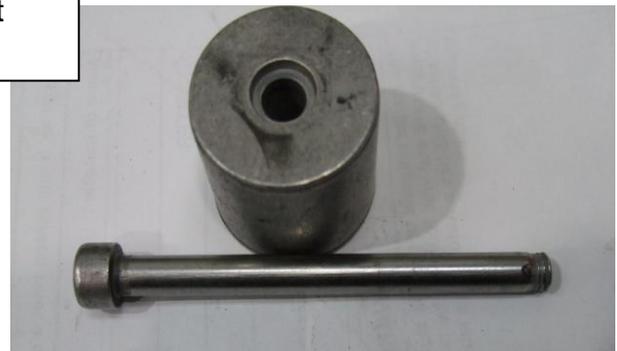
Fig. 7

If the mounting bolts are too tight it will distort the mounting bushing, preventing the hydraulic actuator to pivot on the mounting bolt. All forces are therefore transmitted to the central mounting bolt, which eventually shears.

A too low torque on the central bolt will lead to the load/vibrations being absorbed by the bolt shaft, also resulting in a bolt rupture (Fig. 7).

Also make sure the hole in the alternator bracket is free of rust, dirt and grease, as this again could influence the bolt torque.
