NUMBER 033

Renault 1.4 & 1.6 16V / Synchronous Drive / Installation Info.

GATES REFERENCE:	5501XS, 5671XS & related kits.

MAKE:	DACIA / LADA / NISSAN / RENAULT.	
MODEL:	Clio, Duster, Fluence, Kangoo, Kubistar, Laguna, Largus, Logan, Megane, Modus, Sandero, Scenic, Symbol, Thalia, Twingo, Wind	
MOTOR:	Petrol 1.4 16V, 1.6 16V.	
MOTOR CODE:	K4J/K4M.

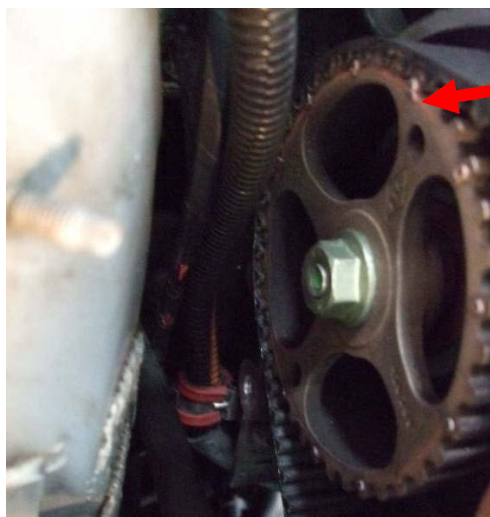
Fig. 1

In this drive, excessive play from the water pump bearing often occurs, this leads to belt tracking forward and forces the camshaft pulley flanges to detach and possibly enter the drive system. The result is belt failure.

Also earlier mechanical damage to the flanges can lead to this (Fig.1).

Flange detached

The camshaft pulley design has changed on these engines (but the OE ref. remained the same), in order to prevent this failure mode.

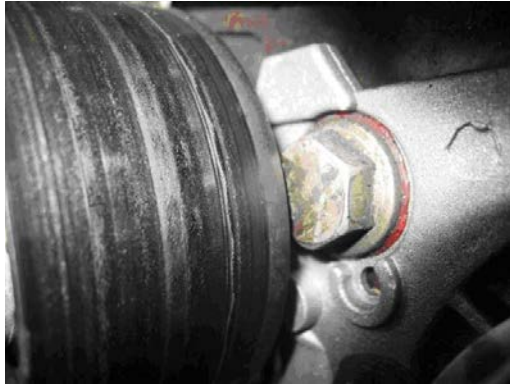
Fig.2

Fig. 2 shows the little space between water pump bolt and tensioner pulley.

We always recommend servicing with a complete water pump kit. While changing the water pump, make sure the correct bolts/washers are used and torqued correctly.

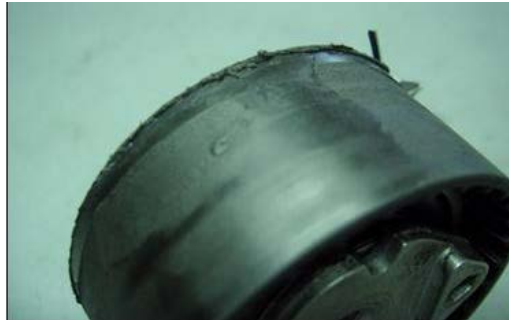
Fig. 3

Incorrect part or bolt coming loose leads to tensioner pulley contact (Fig. 3).

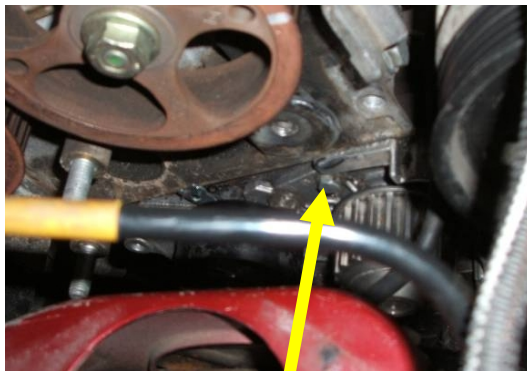
Fig. 4

While installing the new idler pulley, ensure that the spacer (sitting between the old pulley and the engine block) is re-fitted between the new pulley and the engine block. If not, the idler pulley can touch the water pump, causing idler and belt failure (Fig. 4 and 5).

Rubbing mark

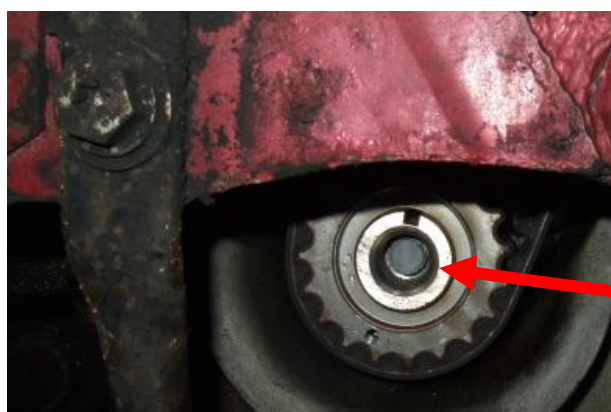
Fig. 6

The crankshaft bolt can't be re-used. (OE ref. is 8200557644. This is supplied with the kit). The correct torque setting of this bolt is very important and varies per engine code or model. Incorrect torque causes bolt shear. (Fig. 6)

Bolt sheared

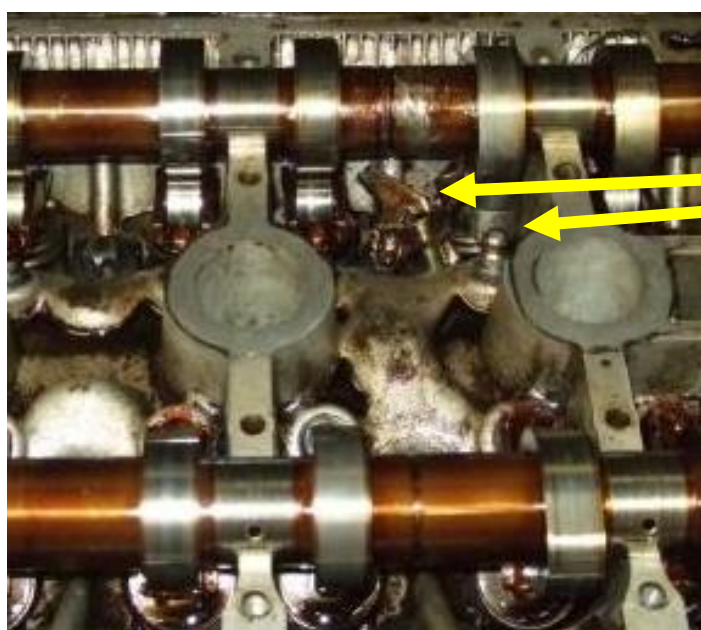
Fig. 7

In the event of an engine repair, after piston to valve contact, a close inspection of the camshaft rockers is essential. It is possible that rockers sustained damage. If so, the rockers must be replaced. Neglecting their replacement causes seizing of the camshaft. (Fig. 7)

Rocker broken
