Technical Bulletin

VAG 2.5 V6 TDI – Timing Belt set-up.

2.5 V6 TDI

AFB, AKE, AKN, AYM, BAU, BCZ, BDG, BDH, BFC.

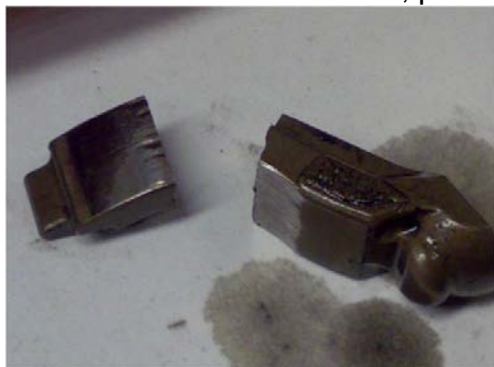
Fig. 1

- 1) Camshaft wear on the early models (up to 2003): there are potential issues with insufficient lubrication of the camshafts. This will lead to power loss, insufficient combustion (exhaust smokes), possible shearing off of the (normal) rocker arms (Fig. 1); resulting in camshaft wear (Fig. 2), blockage and belt rupture. Later models equipped with "roller" rocking arms do not have this issue anymore.
- 2) Although the Timing Belt is tensioned by means of a hydraulic tensioner element, many errors are made during the tensioner setting, leading to premature belt failure.
- 3) In some cases a rough running vacuum pump (hard points) will put extra wear on the belt, possibly leading to premature failure.

It is vital that the correct installation tools (to be found in GAT4450) are used in order to fit the belts correctly. To prevent premature belt failure, always follow the manufacturers' recommended fitting procedure.

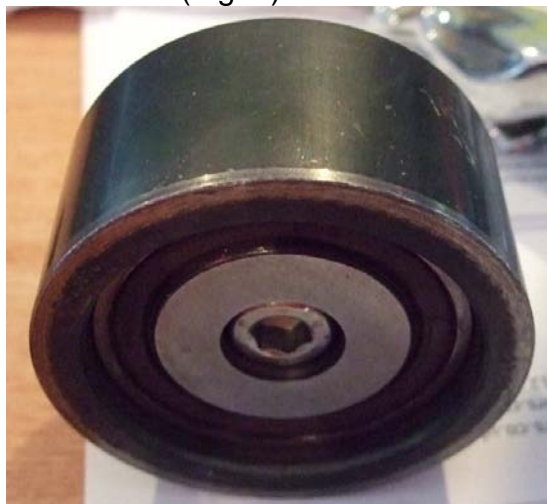
Fig. 6

- 11) Install new idler. **ATTENTION!!!** The idler now has a countersunk hole (Fig 6), needing a shorter bolt (supplied in the kit). Failure to use the correct bolt will lead to incorrect clamping, with a sheared bolt as a result (Fig. 7)

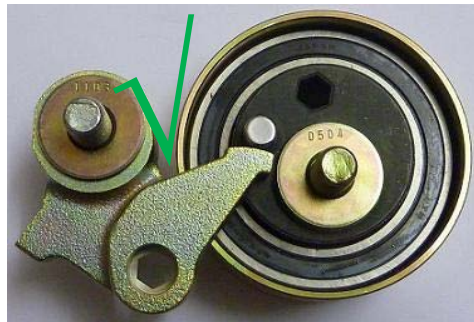
Fig. 8

Fig 8 shows the only possible **correct** lever/pin contact.

Correct

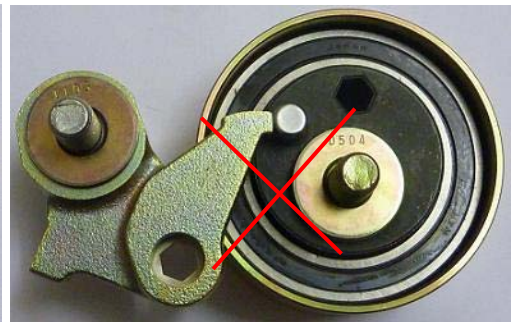
Fig. 9

Incorrect

Any incorrect contact of the lever arm with the pin on the tensioner, or lack of washer, will cause serious damage to the system; with belt failure as a result (Fig.10).

Do not forget (1) washer behind lever and tensioner pulley!!
