027

Technical Bulletin

FORD 1.8 Diesel engine.

GATES REFERENCE :	5541XS/K015541XS
MAKE :	FORD / MAZDA
MODEL :	C-Max, Courier, Fiesta, Focus, Galaxy, Mondeo, S-Max, Tourneo Connect, Transit Connect
ENGINE :	121
ENGINE CODE :	1.8 Diesel (all 8 valves) Various

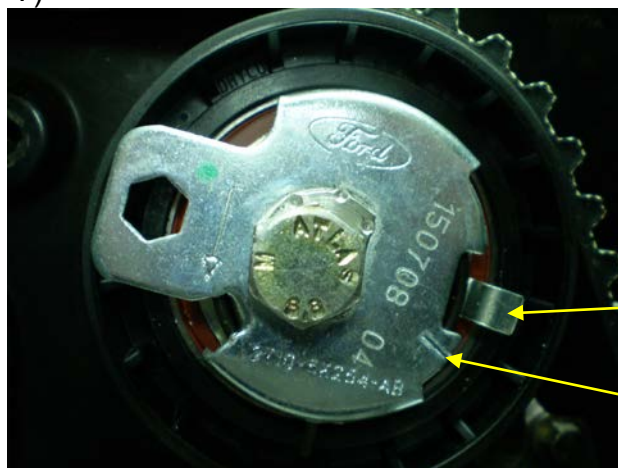
Fig. 1

Indicator in middle of the slot. ✓

Mark on the tensioner

- 1) Engine must be cold: the engine temperature significantly influences the installation parameters
- 2) Engine must be at TDC. All engine specific setting/locking tools can be found in Gates tool kit GAT4830
- 3) The crankshaft has to be blocked (when equipped with air conditioning, the alternator shaft has to be removed, 6 bolts to loosen).
- 4) The camshaft has to be blocked (at the back of the engine)
- 5) Camshaft sprocket bolt has to be loosened. Make sure sprocket is free to rotate on the taper, by using the sprocket remover in tool kit GAT4830 (if not done so, the belt will not be tensioned in the top span)
- 6) The tensioner must be turned anticlockwise, until the indicator is in **the middle of the slot (not lined up with the mark on the tensioner)** (Fig. 1)
- 7)

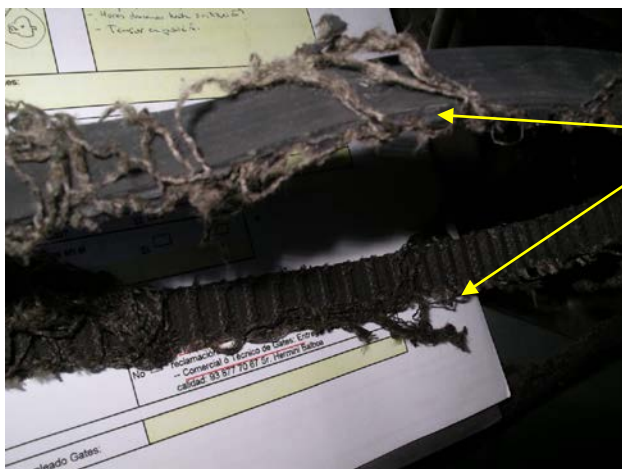
Failure to do all the above will lead to wrong tension, with possible tracking of the belt as a result. The belt will climb over the camshaft sprocket flange, running into the timing cover (Fig. 2 and 3)

Fig. 2
Typical wear pattern on the side of the belt

- 8) Torque the tensioner bolt (50 Nm) **while holding the tensioner in place**
- 9) Torque the camshaft bolt (50 Nm) **while holding the sprocket in place**. Use Gates sprocket holding tool GAT4844.
- 10) Remove the camshaft and crankshaft locking tools
- 11) Turn the engine nearly 6 revolutions by hand
- 12) Re-insert crankshaft pin, rotate engine further till TDC
- 13) Check the tensioner indicator position, if not in the middle of the slot, restart the tension setting procedure
- 14) Insert the camshaft locking tool (at the back of the engine). If not possible, restart the tension setting procedure

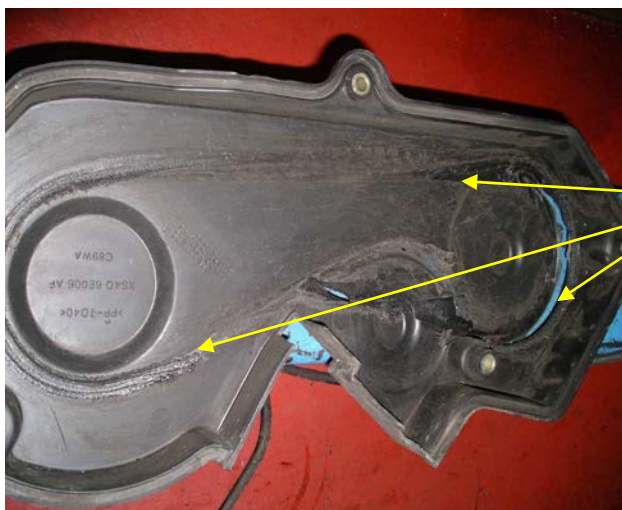
Fig. 3
Signs of serious wear on inside of the cover due to contact with the side of the belt

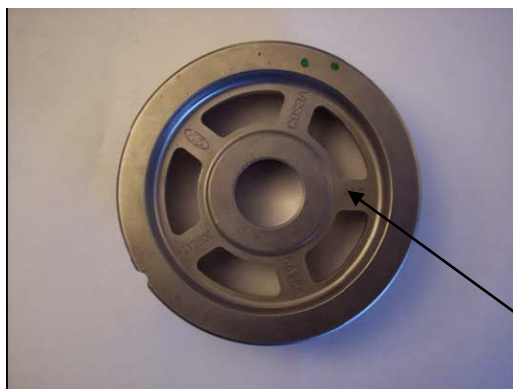
Fig. 4

Extension AC

Check if the part number of the camshaft pulley ends with **AC** (Fig. 4). Should the part number of the camshaft pulley end with **AB**, fit new sprocket with OE ref. XS4Q6A256**AC**.

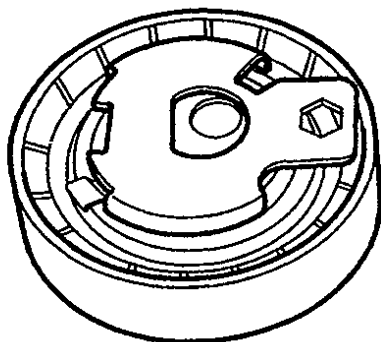
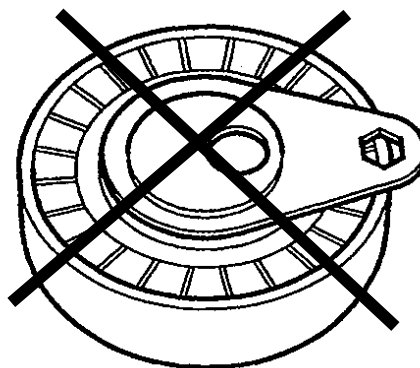
New automatic tensioner

Old manual tensioner

Fig. 5 shows the initial manual tensioner on the right side and the current automatic tensioner on the left.
