AN OPPORTU

CASE STUDY I

Engine: Ford 1.8 Endura Diesel
Models: Escort, Mondeo and others

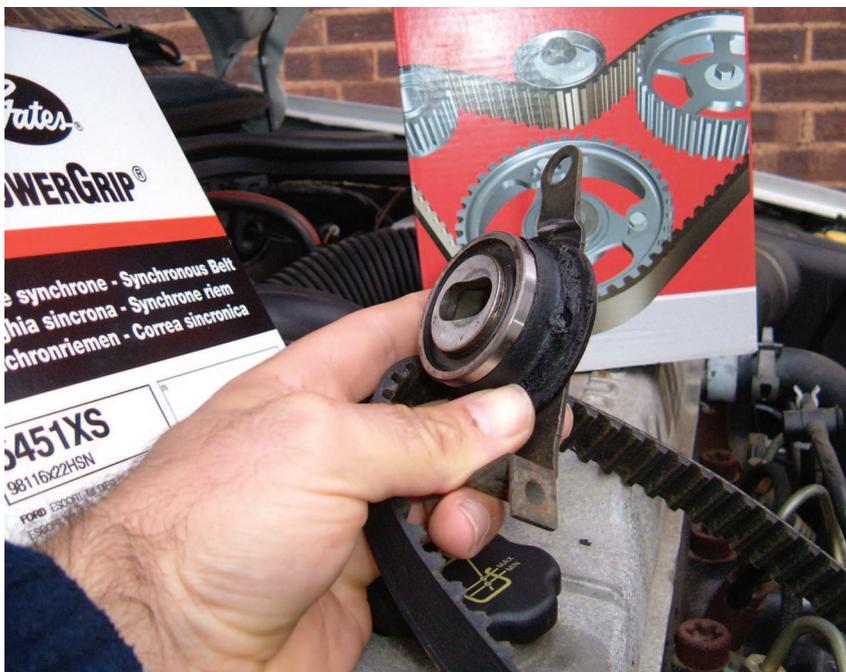
And yet, less than seven months later, the belt had failed in extraordinary circumstances. The surface of the tensioner had suffered a complete and unexpected 'melt-down'.

The initial Gates report about the Ford Mondeo suggested that the failure of the belt and the effect on the tensioner was the result of an overheating problem. This was attributed to either excessive pressure from the belt, dirty or worn pulleys (creating poor running conditions) or, more likely, pulley seizure.
