An INSPECTION

CASE STUDY

Manufacturer: Audi
Model: 100
Engine: 2.5 Tdi
Year: 1991-94

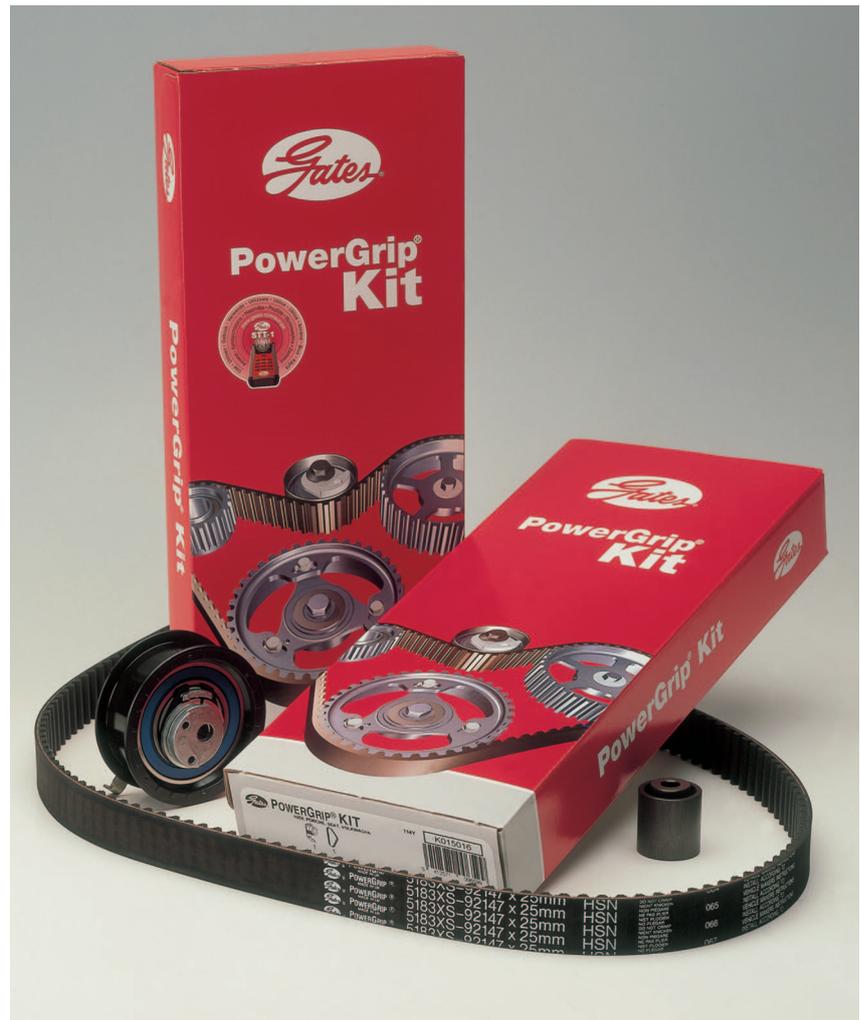
The first suggestion that the garage technician might have been on the wrong track followed a closer look at the hole in the cam cover. It seemed more likely that something — a foreign object, perhaps — had been ejected and that this was in fact an exit wound. The second clue was found on the belt itself. The thorough examination had revealed a small envelope-like 'tear' on the surface.

The location of the tear, centrally, rather than on either edge of the belt, seemed to rule out the engine block or the cam cover as a likely source of abrasion. It was more likely that a foreign object had become trapped between the pulley and the belt, causing damage to the tensile cords. On the other hand, the drive system compartment itself showed no real evidence to suggest how a 'foreign' object might have gained entry. There were no traces of dirt or oil, which might also have been present as a result of leakage in the drive system.

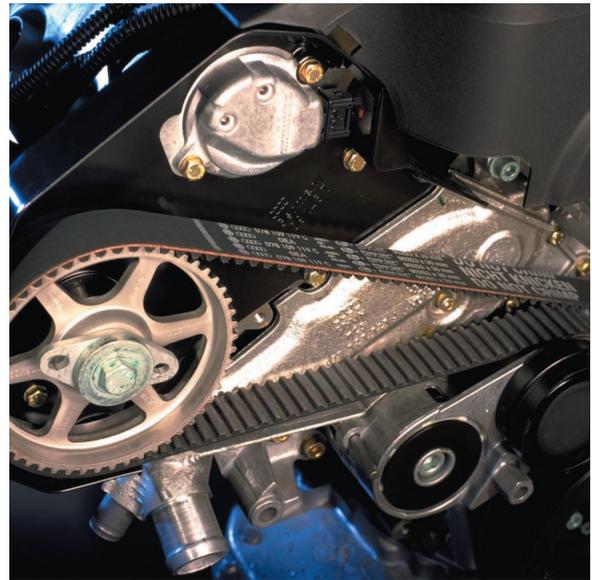
The finger of suspicion was beginning to point at the drive system itself. Once the tensioner was removed, the evidence was irrefutable. Part of the tensioner had

broken away. There was little doubt that this fragment had come adrift, become trapped between the pulley and the belt, causing the surface damage to the belt. This had led to the damage of the tensile cords, resulting in the premature failure of the belt. The evidence suggested that it had subsequently created a hole in the cam belt cover and made its escape.

A garage technician has to be satisfied that, having replaced the belt, the metal parts are more than capable of surviving another complete duty-cycle. In other words, if belt kits were to be specified on every occasion, tensioners would always be replaced at the same time as the belt, making potential failures, as in this case, less likely to occur. Case closed.
