Technical Bulletin

Tension setting on Mitsubishi/Volvo 1.8 16V petrol engines

| GATES REFERENCE : | 5514XS/K015514XS | |
| MAKE : | MITSUBISHI / VOLVO | |

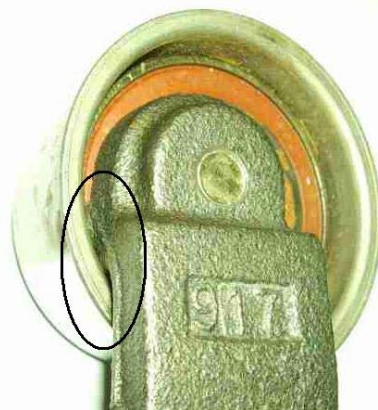
Fig. 2

- 1) Manipulating the tensioner correctly, but not completely following the recommended tension setting procedure. This leads to incorrect tension with a premature belt failure as a result.
- 2) Turning the tensioner in the wrong direction - clockwise. This leads to incorrect tension and very often tensioner seizure. The tensioner bracket touches the pulley, obstructing it to rotate freely (Fig. 2)

If the tensioner pulley is turned in the correct – anti clockwise - direction, it will not be able to come into contact with the bracket (Fig. 7)

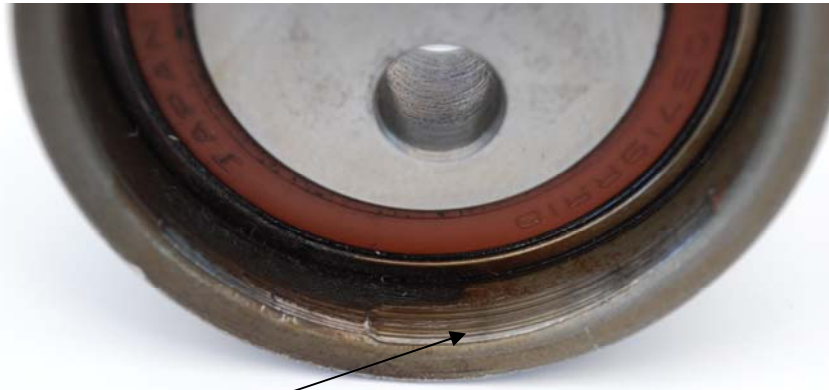
Fig. 3

Evidence of this can be found on the back inner side of the tensioner pulley. (Fig. 3)

Rubbing mark

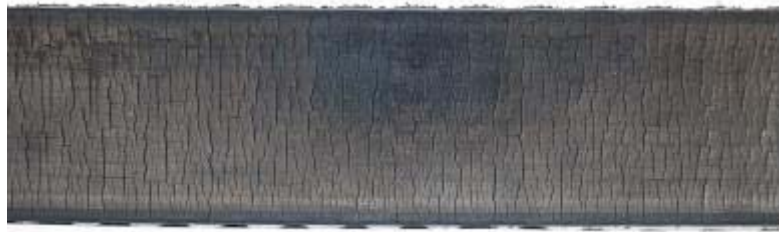
Fig. 4

Since the pulley cannot rotate anymore, the belt back - constantly rubbing against the pulley surface - will start to overheat and crack (Fig. 4).

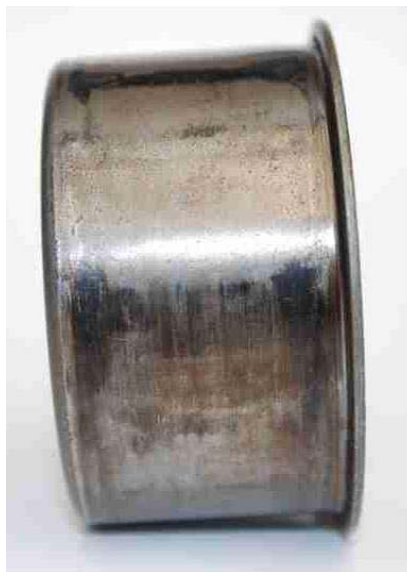
Fig. 5

This excessive temperature is further transmitted to the tensioner and idler pulleys, leaving a blue heat mark on the pulleys (Fig. 5), and possibly even traces of melted rubber (Fig. 6).
