Technical Bulletin

DriveAlign® Tensioner T38192

T38192/K046PK1660

1.9 Tdi 8V

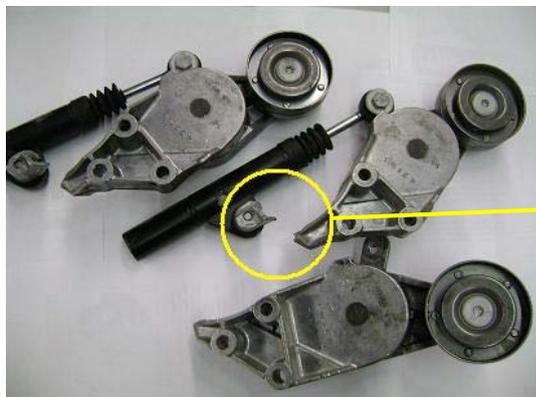
Fig 1

Different failures of this tensioner have led to garage visits where the reason of the early failures of this tensioner were investigated. During the examinations, the malfunction of the OAP was proven. The OAP not working properly anymore leads to abnormal belt vibrations, causing the tensioner bracket to be affected by material fatigue; leading to rupture (Fig. 1 and 2).

The bracket will always shear at the same point (just above the connection of the bracket with the hydraulic damper).

The broken tensioner bracket is the result of excessive vibrations, not the cause!

- Worn Overrunning Alternator Pulley
- Solid pulley installed instead of an OAP
- Using an OWC (One Way Clutch) instead of an OAD (Overrunning Alternator Decoupler)

The OAP is a wear item, which has to be regularly checked for proper function.

Replace the alternator pulley with the prescribed Gates part.

Follow OE recommended installation procedure.

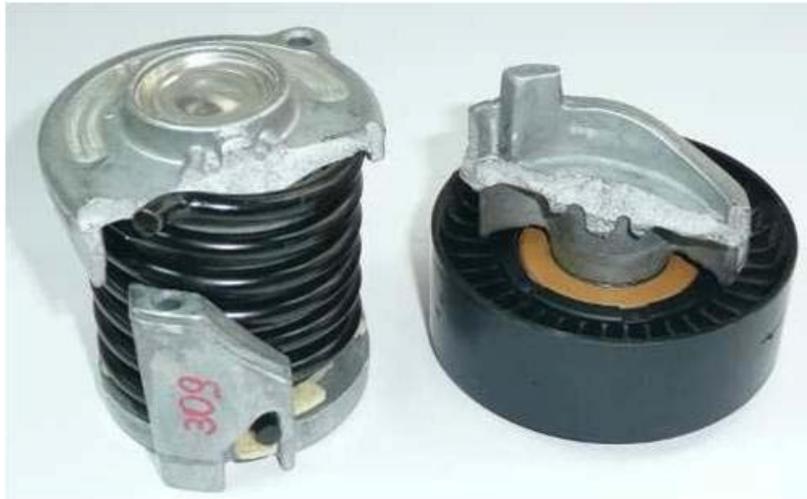
Fig. 3

Also in other cases worn/blocked OAP's have led to the failure of the tensioner (Fig. 3).
