RIGHT ON

CASE STUDY I

Engine: VW/ Audi 1.9 diesel group

CASE STUDY 2

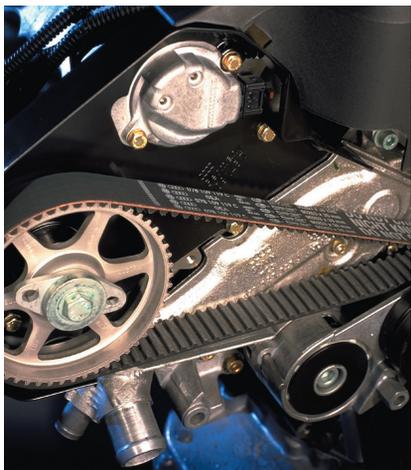
Gates supplied the OE belt for the original VAG 1.9 diesel engine group and subsequent enhancements mean that the replacement belt, (5223XS), has been improved. It now displays a different tooth form than the original belt, although identical to the current OE belt 028 109 119P.

The new profile is designed to run in the same pulleys as the former OE belts and works better than any formerly approved OE belt. However, the procedure for installing the new profile belt has changed and that's where it gets more difficult.

If this method is not followed, it is impossible to install the belt. The belt seems too short. It cannot be fitted over the pulleys in the normal way.

Even with this better Gates' belt problems can still occur on '96, '97 and '98 models, on which the injection pump bracket could cause misalignment. The result can be that the timing belt runs against the upstanding flange of the vibration damper (installed on the crankshaft) and also against the tensioner pulley flange. The width of the belt reduces slowly, producing a very shiny sheen on the side of the belt. Typically, it can reduce from its original width of 1 in., to something closer to $\frac{3}{8}$ in — before it breaks.

- The camshaft pulley must be removed by knocking a pin through the hole in the rear timing belt cover.
- The belt has to be fitted around the pulley.
- Refit the pulley and belt at the same time.

When this occurs, the injection pump bracket has to be replaced by the newer version (same OE number).

before installing the new timing belt. It is wise to let the engine idle for a few seconds before the vibration damper (the crankshaft Micro-V pulley) is installed again, in order to ensure the belt is no longer tracking. The belt should sit between 1.5 to 4mm away from the pulley front side.

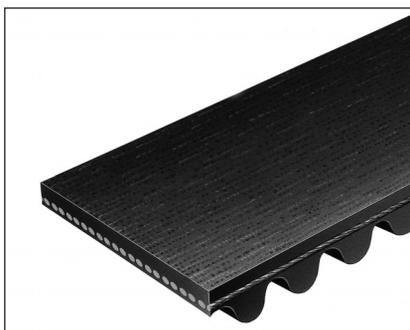
Basic security checks can be flawed. All of the belts have the same number (153) of teeth. The width difference can vary by as little as 0.6mm, from 25.4 to 26mm between belts.

it's always worth taking a sideways look at the belt. For example, the belt with a 58 tooth profile has teeth that go straight up and down. The teeth on the belt with 76 tooth profile slant sideways. However, a profile check is not a guarantee that the belt is correct because the construction of the replacement belt may be incorrect.

- Check the original Renault part number if still visible on the old belt.
- Look up the engine code on the engine block. It's near the junction with the gearbox.
- Always cross reference the replacement belt with the OE specification.

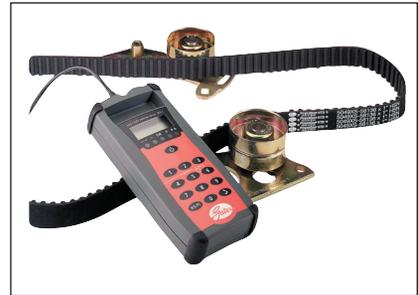
For instance, Renault prescribes a specific tooling procedure in order to ensure the correct operating tension. At aftermarket level, many installers do not use an appropriate belt tension-measuring gauge. Instead, a 'guesstimate' is often made. The installers often use the 'thumb' — in other words, they rely on 'experience' rather than instrumentation.

Consequently, the belt is often set too slack and rubs on the injection pump pulley cover. The evidence of this is plain for all to see. Marks on the belt itself indicate this problem clearly.

Nearly all of these models are equipped with a manual tensioner. The tension can be checked (and adjusted if needed); using a specialist tool. The Gates STT-I tension tester is suitable for this job. It replicates the sonic

testing process used to test timing belt tensions on the assembly line.

The spot where the tension has to be checked can be found on each timing belt box. Alternatively, check the brochure supplied with the STT-I.
