THE DATA

Procedure and protocol

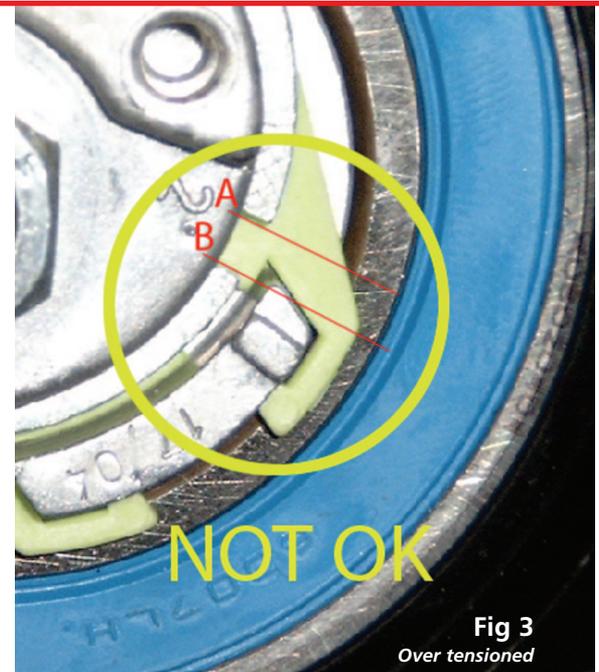
Fig 3
Over tensioned

tension has been set too low. If the pointer has moved beyond point B (Fig 3), the tension is too high.

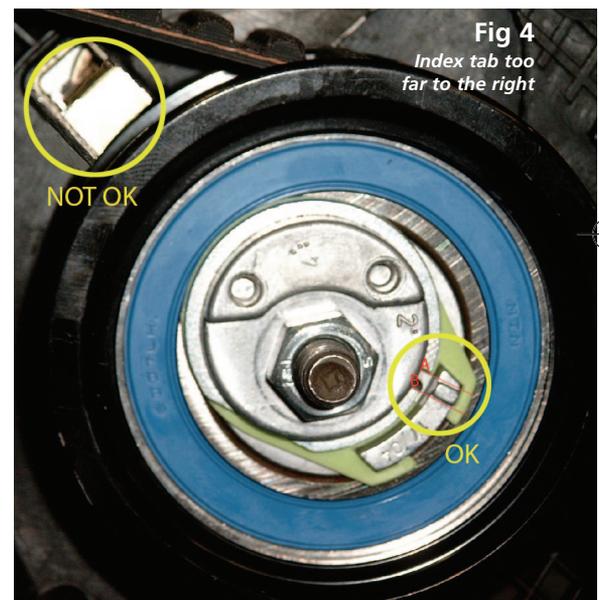
Fig 4
Index tab too far to the right

It is also possible to position the pointers perfectly between A and B, while the index tab is not 'locked' in its slot (Fig 4). If this happens, the belt will lose tension once the engine is started.
