# SPLIT DIE

**The Gates technical inspector uncovers an unknown timing belt issue for a particular engine and underlines a call for a formal inspection procedure.**

## CASE STUDY I

**Vehicle:** Citroën  
**Model:** Berlingo  
**Engine:** 1.9 Diesel

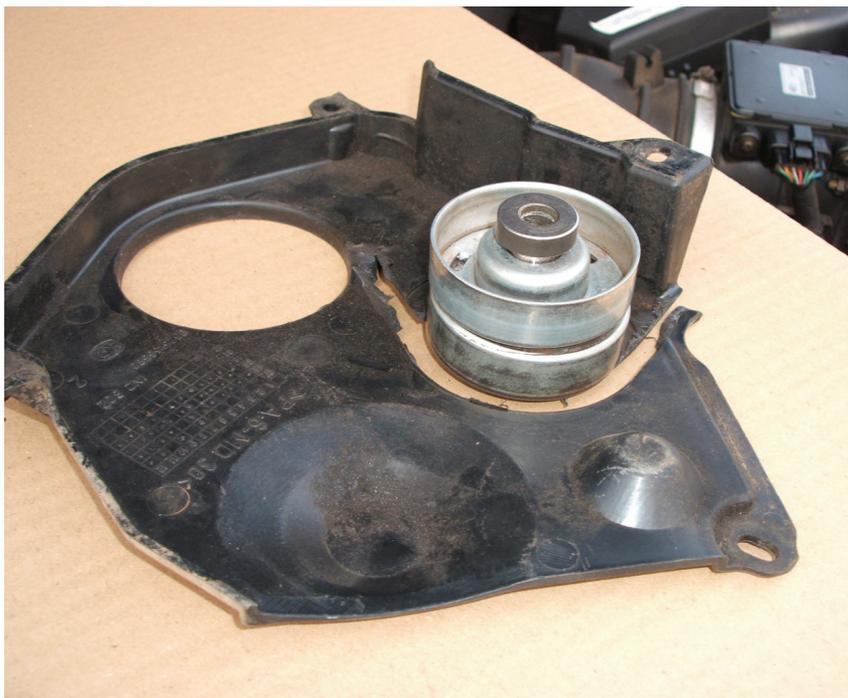
The tensioner on this particular engine model is distinctive. It is made in two parts, which are riveted together. The two halves had parted, ultimately leading to a belt failure. But this was not the end of the story.

Gates always recommends that all of the metal parts should be replaced at the same time as the belt. In association with an itemised inspection of all the other components, it forms part of a drive system overhaul. A Berlingo belt kit was fitted and the problem was resolved.
