# Technical Bulletin

## SOFIM 2.4 / 2.5 / 2.8 Diesel engines

<b>GATES REFERENCE :</b>	<b>5039 (K01), 5113 (K01), 5334XS (K01), 5335XS (K01), 5495XS (K01)</b>	
<b>MAKE :</b>	Fiat / Iveco / Opel / PSA / Renault	
<b>MODEL :</b>	Various	
<b>ENGINE :</b>	2.4 / 2.5 / 2.8 / D, TD, DTi, DTic, Dci, JTD, HDi (all 8 valves)	
<b>ENGINE CODE :</b>	Various

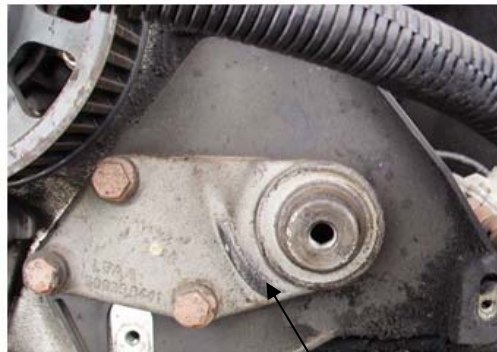
Fig. 3

Misalignment will also lead to the belt coming in contact with the back plate. This will leave a rubbing mark on the back plate (Fig. 3).

Rubbing mark

- Always check the play between the axle and the bearing. If there is excessive play, replace axle/back plate
- Always apply the OE recommended tightening torque; it is very important as it determines the preload of the bearing.
- Always use fixing glue in order to avoid the bolt/nut coming loose due to vibrations and thermal expansion/contraction of the different metal parts (if the bolt/nut loosens, the bearing falls apart) (See Fig. 6).

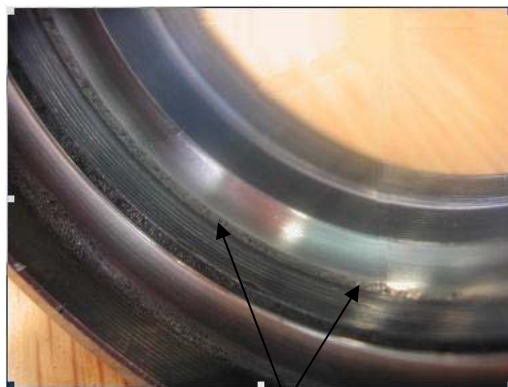
Fig.4

Figure 4: Bearing balls rolling outside their track due to misalignment and incorrect torque setting

Ball traces

- A correct tightening torque on a badly positioned bearing or a dirty axle will result in a failure.
- The tension on the belt also affects the performance of the idlers on this engine. Use Gates STT-1 sonic belt tension tester for correct belt tension setting.

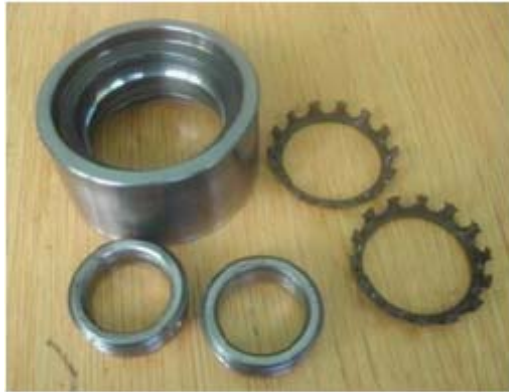
Fig. 6

Figure 6: Too low tightening torque will lead to the bearing falling apart.  
Figure 7: Deformation of the balls because of excessive temperature, resulting from too high tightening torque.

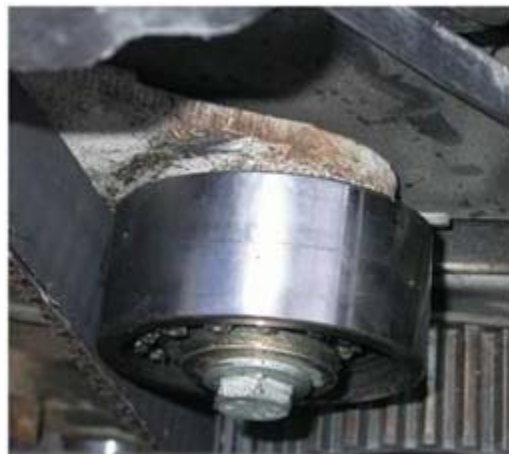
Fig. 8

Figure 8: Seal has come out of the bearing and ball cage has been destroyed.

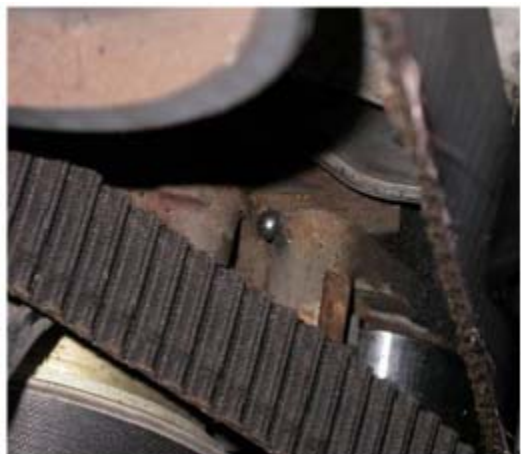
Fig. 9

Figure 9: One often can find balls in the lower engine compartment. Remove all debris from the drive system
