Certain issues should always be considered when replacing timing belts. Gates reports on the causes of premature failure.

CASE STUDY

Manufacturer: Nissan
Model: Micra K10
Engine: 1.0 litre
Year: 1990

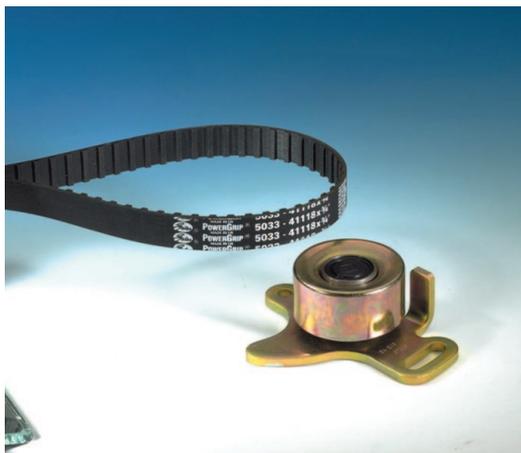
tension of the belt. Damage to the belt itself could indicate a misalignment issue. A foreign body (stone-chips, for example) could be a cause. In the case of the Nissan Micra, the belt had been shredded. If

shredding occurs on the inside-edge, evidence of scouring or scuffs on the engine block is likely. On this occasion, the damage had been caused on the outside-edge and the evidence was visible on the timing belt cover.

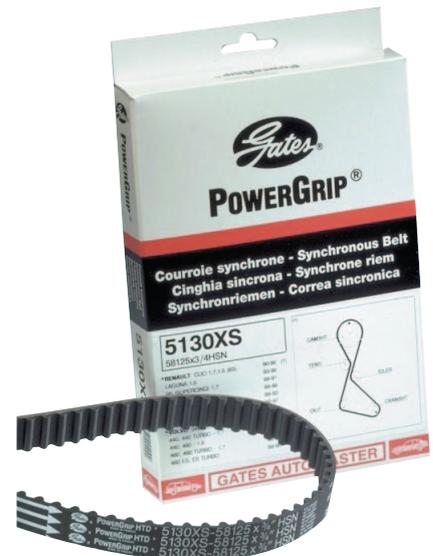
In order to determine the cause of the misalignment, all of the related components were examined. As the oldest component in the drive system, the tensioner was a prime suspect. Sure enough, there was evidence of 'play'. The bearing could be moved with very little effort from side to side.

A leaking water pump would normally suggest significant wear to the pump's bearing. It also suggests that other components in the drive system are also worn (ie tensioners and pulleys). There was no doubt that the tensioner was the cause

of the misalignment. The worn tensioner should have been replaced when the new belt was fitted. This belt had very little chance of completing a full duty-cycle.

the garage accepted responsibility for the consequential engine damage because, in accordance with good workshop practice (and as highlighted in various manuals associated with timing belt replacement procedures), the worn tensioner had not been identified when the timing belt was changed.

Timing belts are vital components in today's technologically laden engines. The metal parts of the drive system should be replaced every time the belt is changed. That's because the technician — and indeed the garage proprietor — can have no reasonable expectation about the future performance and longevity of the metal parts that are in-situ.
