Technical Bulletin

VAG 2.5 V6 TDI – Timing Belt set-up.

2.5 V6 TDI

AFB, AKE, AKN, AYM, BAU, BCZ, BDG, BDH, BFC.

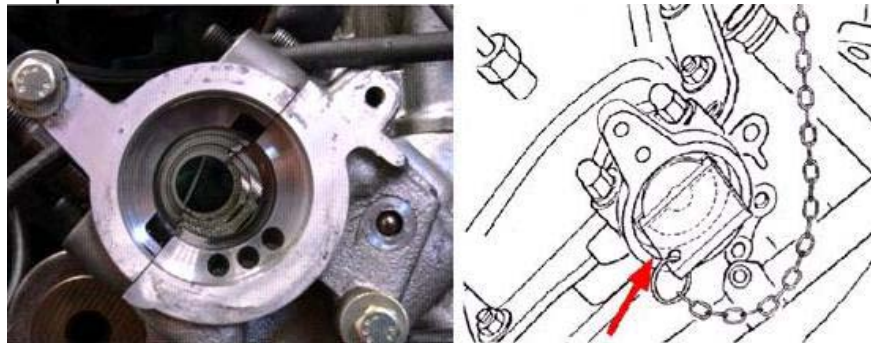
Fig. 5

NOTE: Setting plates **cannot** be used to hold camshafts in place when releasing sprocket bolts. They are only for holding timing position!

- 2) Remove the TDC cap from the engine block and put in the crankshaft locking pin (GAT4401); which is used to retain the crankshaft at TDC position. The locking pin has to be screwed in via a threaded hole in the crankcase (Fig.4).
- 3) By removing both camshaft cover (cap) and the vacuum pump at the back of the cylinder heads, you will be able to put the camshaft setting plates (GAT4451) in the slots in the rear of each camshaft (Fig. 5). They are supplied with chains which are attached to a suitable engine part to prevent them from falling.
