Technical Bulletin

Tension setting on Mitsubishi/Volvo 1.8 16V petrol engines

| GATES REFERENCE : | 5514XS/K015514XS | |
| MAKE : | MITSUBISHI / VOLVO | |

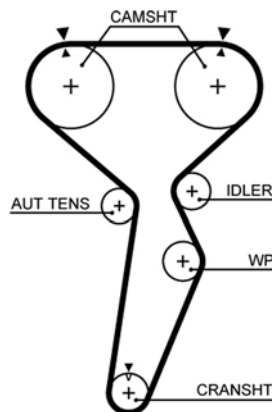
Fig. 1 shows the drive lay out of this engine, with correct position of the timing marks.

Put engine at Top Dead Centre (TDC), with Timing Marks (TM) aligned (see Fig. 1) by rotating the crankshaft clockwise.

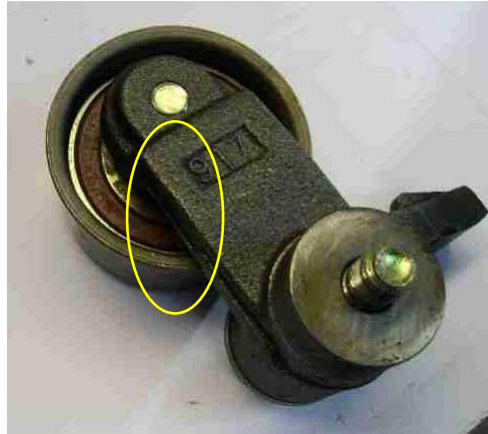
Fig. 7

If the tensioner pulley is turned in the correct – anti clockwise - direction, it will not be able to come into contact with the bracket (Fig. 7)

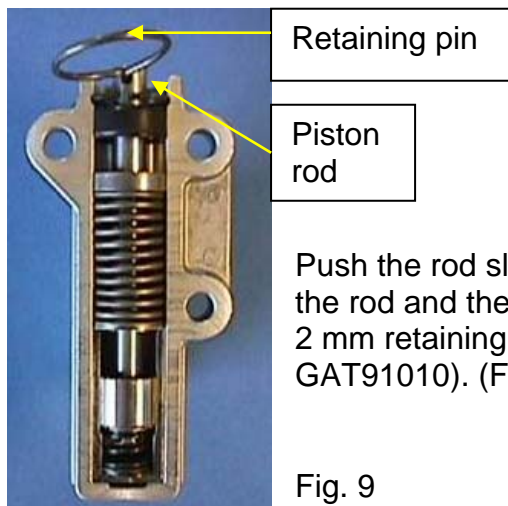
Fig. 9

By now, the piston rod of the hydraulic tensioner has come out of the tensioner body by 10.5 to 11.5 mm. If not, or leakage is present, replace the tensioner.

Apply a pressure of 10 to 20 Kg on this rod; movement of the rod should be maximum 1 mm. If more, replace the tensioner.

Push the rod slowly down (vertically) until the holes of the rod and the tensioner body are in line. Insert a 2 mm retaining pin (can be found in GAT4657 or GAT91010). (Fig. 9)
