Technical Bulletin

Tensioning issues on Chevrolet/Daewoo 16V petrol engines

5419XS/K015419XS

Chevrolet/Daewoo

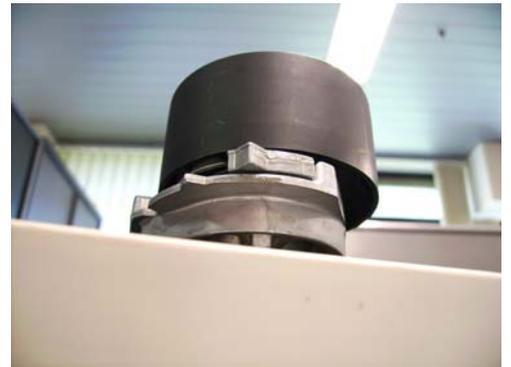
Fig. 3 shows where the pointer is situated on a good tensioner (in its rest position).

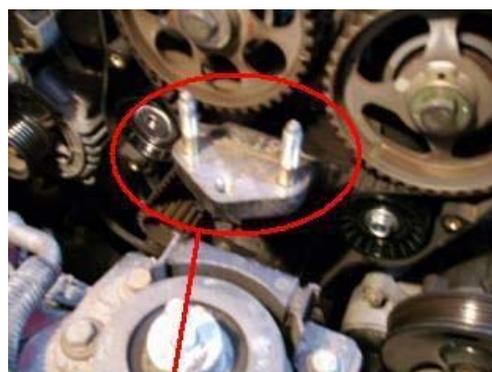
Fig. 4

In order to make access to the drive easier, it is recommended to remove the engine support (Fig. 4)

engine support

7. tighten the water pump bolts
8. re-install engine support
9. re-install the removed auxiliary belt crankshaft pulley

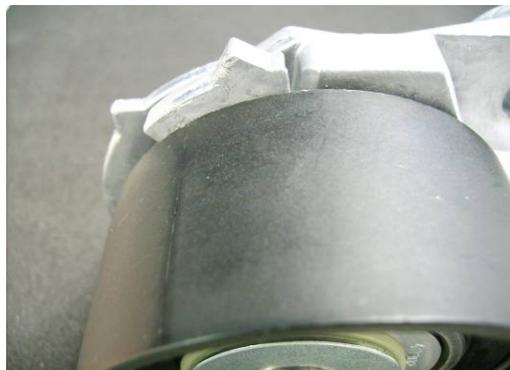
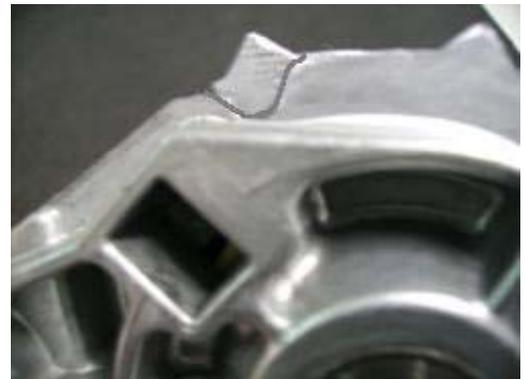
- Install a new tensioner and idler, and fit the new belt (anticlockwise, starting from crankshaft). Use kit K015419XS.
- adjust tensioner pointer up to the notch in the tensioner back plate - close to the right hand stop - by rotating the water pump gently clockwise (Fig. 6, 7 and 8).

Fig. 6 View from front

Fig. 7 View from back

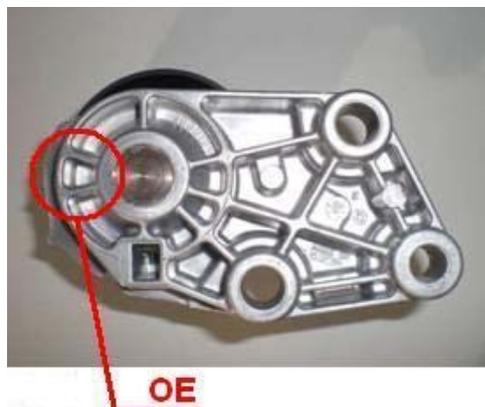
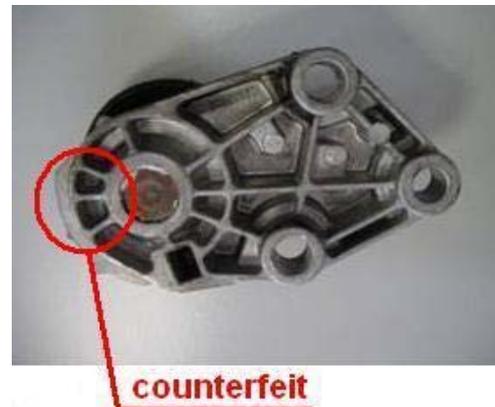
In addition, one has to watch out for counterfeit tensioners which can be widespread in certain markets (Fig.10 and 11)
