cam belt clinic

CASE STUDY

Vehicle: VW
Model: Transporter
Year: 1996
Engine: 1.9 Turbo Diesel ABL

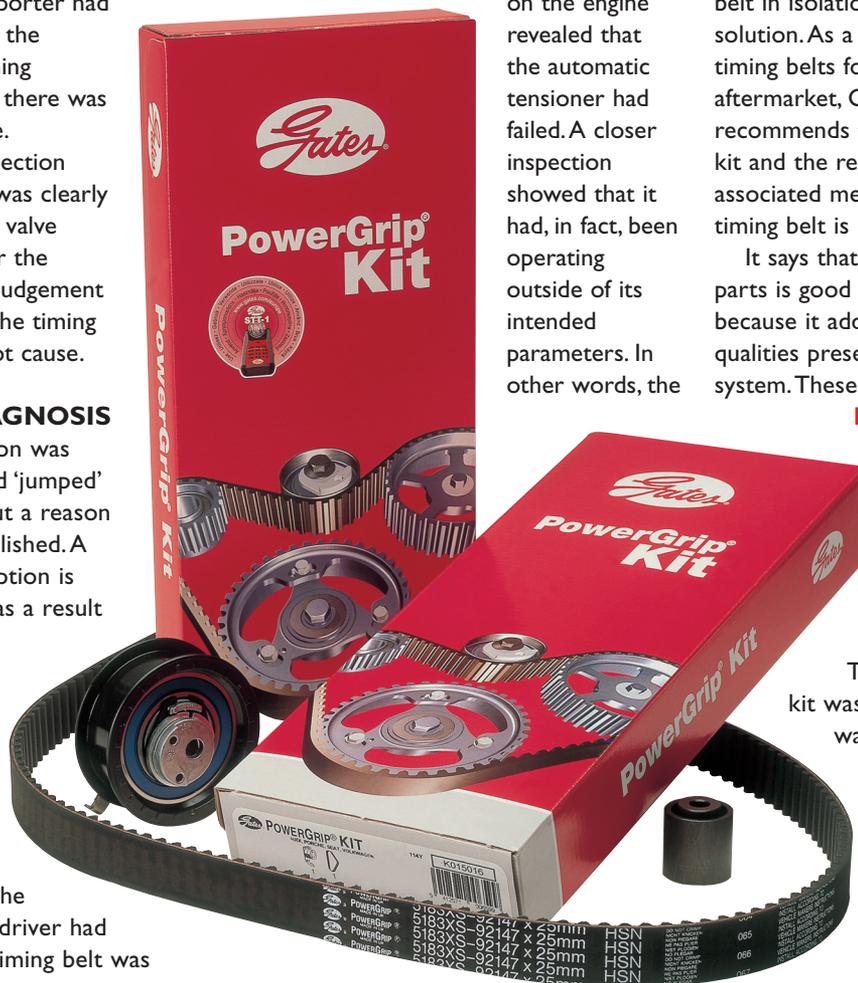
Within a very short period of time, the engine was back once more and the same faults were reported. Once again, the injection pump and valve timings were 'out'. Further investigation of the drive system on the engine revealed that the automatic tensioner had failed. A closer inspection showed that it had, in fact, been operating outside of its intended parameters. In other words, the

required amount of movement necessary to automatically tension and slacken the belt was being exceeded. The stops had completely broken off. However, for a second time, the reason why was never established.

This time, a timing belt kit was used. The tensioner was replaced and a second new belt was installed even though the existing belt had run for only a very short distance and a very short period of time.
